Flightfax

Online Report of Army Aircraft Mishaps

Mishap Review: AH-64D Maintenance Error

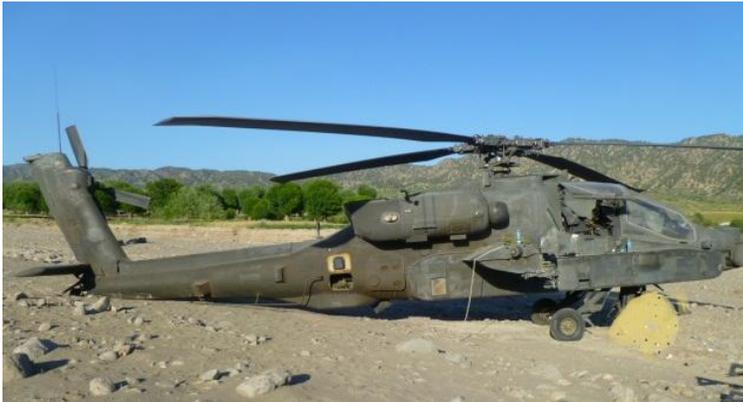
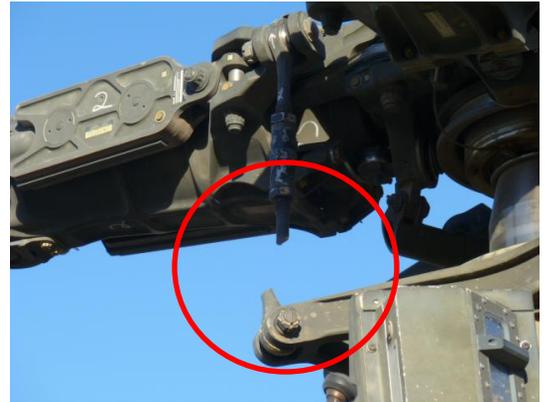
The AH-64D was conducting an escort mission. Eleven minutes into the mission, the aircraft experienced violent vibrations with a left yaw and nose down rotation, accompanied by a rapid descent. The crew was able to establish a level attitude and controlled descent to the ground with a roll-on landing. Significant damaged occurred during the hard landing but no crew injuries.

It was determined the severe vibrations caused the failure of the lower rod end bearing of a PC link. The bearing failed by becoming unstaked, allowing the rod end to slide against the rotating swash plate. This action resulted in the lower bearing becoming fixed in one position. With the upper bearing not having enough bearing movement to accept the torsion load, the PC link failed by snapping due to torsion twisting.

It was determined that errors in maintenance procedures had allowed a suspected unserviceable part to be installed on the aircraft. The PC link in question had been removed from service more than a year prior to the accident with a DA Form 2410 indicating a failure code 710 (bearing or bushing failure). At the servicing AVIM, the PC link was taken to the repair shop. While in the repair shop, the part received a TI stamped yellow tag (serviceable), but the DA Form 2410 was not updated to indicate repair to the part. The part was put back into the Tech Supply system. Subsequently, the PC link was installed on the accident aircraft and failed 144 hours after installation. QC personnel failed to properly verify the serviceability of the PC link prior to installation. It is critical that all maintenance records be maintained accurately in order to ensure all required maintenance and inspections are being completed on time and to the proper standards. A breakdown in maintenance procedures allowed a suspected unserviceable part to be installed on an aircraft.

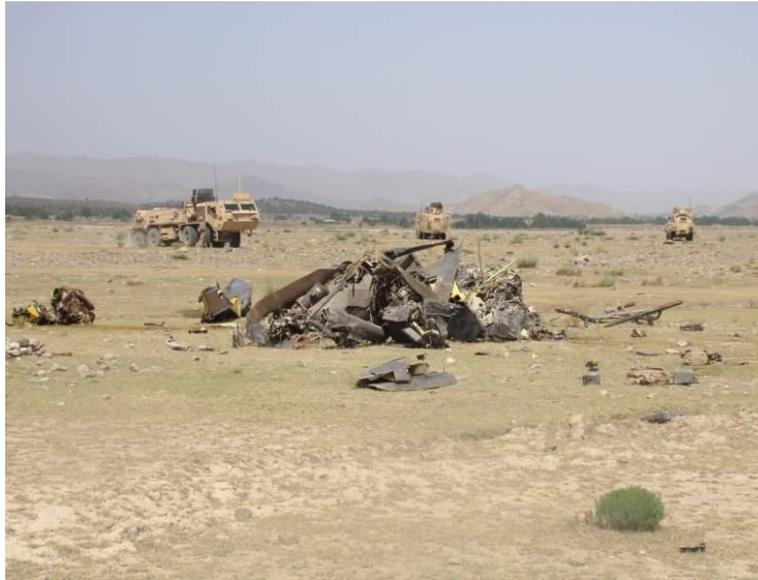
Mishap Review: OH-58D Diving Fire

While engaging enemy combatants during a quick reaction force mission, the accident aircraft impacted the ground at high airspeed. The impact fatally injured the two pilots and destroyed the OH-58D.

While engaging enemy combatants, the crew became fixated on the targets and failed to maintain a proper scan during the diving fire engagement. With factors such as the steep angle, out-of-trim condition, slight tail wind, high DA and high gross weight of the aircraft, the PC maneuvered the aircraft at a high airspeed/rate of descent below a recoverable altitude. Due to the excitement and haste to engage the enemy, a breakdown in crew coordination contributed to this event in that the PC did not effectively communicate his decisions to the PI or seek supporting information. The PI did not cross monitor the PC's actions, resulting in the aircraft being maneuvered below a recoverable altitude. The crew coordination remains pertinent for all crews, regardless of the experience of the crewmembers. Discipline, in execution of crew coordination for a mission, begins with mission planning and continues throughout the mission.
