Flightfax[®]

Online Report of Army Aircraft Mishaps

Mishap Review: AH-64D Loss of TR Thrust

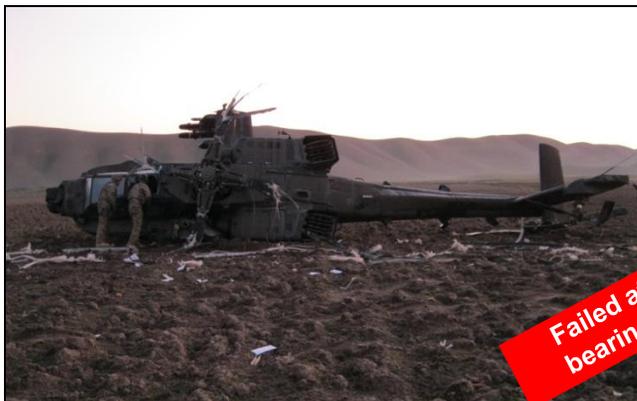
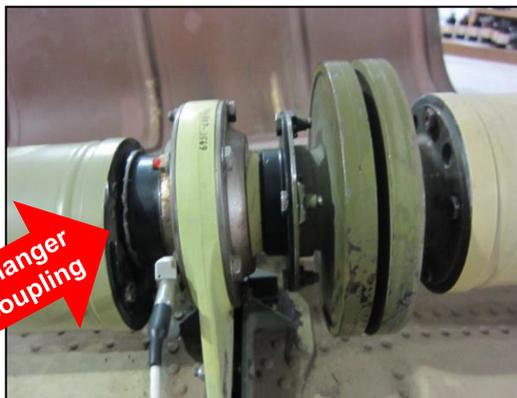
Failed aft hanger bearing coupling

While responding to support troops in contact, the AH-64D crew experienced a loss of tail rotor thrust when the aft hanger bearing coupler sheared at the #5 tail rotor shaft. The crew was forced to land to an unimproved field. After touchdown, the aircraft rolled onto its left side.

The accident board determined that the #5 tail rotor driveshaft vibrated and caused the aft hanger bearing coupling to shear due to improper maintenance. One week prior to the incident, the intermediate gearbox and #5 tail rotor drive shaft were removed to complete other maintenance tasks. During reinstallation of the drive shaft, the hanger bearing bolts were installed without appropriate torque. The repair occurred over a two day period, requiring two maintenance hand-offs between the day and night shifts. The day shift installed the hanger bolts, but left the torque requirements to the night shift. The task was signed off and Tied with inadequate torque applied. Prior to the accident day, the aircraft had completed a dynamic drive MOC as well as a short flight that was aborted due to poor weather. The aircraft was equipped with a modernized signal processing unit (MSPU), which recorded a caution for vibration in the aft hanger bearing and driveshaft area during the MOC and each subsequent flight. The MSPU data was only required to be downloaded every 14 days or 25 flight hours. The board recommended that MSPU data be reviewed following dynamic drive MOCs. Additionally, the board determined the battle captain failed to follow proper procedures in approving the one-time maintenance recovery flight without notifying the commander, and the aircrew failed to diagnose and properly respond to an emergency condition when the gearbox vibration caution message illuminated (land as soon as possible).

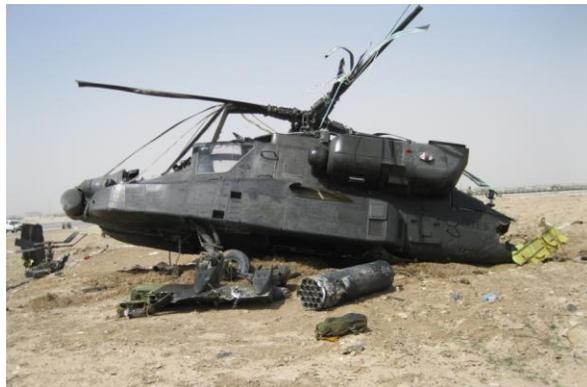
During the conduct of a MTF, at an altitude of 200 feet AGL and airspeed below ETL, the aircraft developed a high rate of descent until ground impact. The crash resulted in serious injuries to one crewmember and substantial damage to the aircraft.

The aircraft contacted the ground in a 10 degrees nose low attitude and 20 knots forward groundspeed resulting in significant damage. Additionally, the main rotor contacted the forward crew station resulting in serious injuries to the pilot.

The accident board determined the crew failed to identify the initial rate of descent developed during the downwind pedal turn. This, and the slow application of available aircraft power, resulted in the aircraft developing a high rate of descent from which the crew was unable to recover.
