# Flightfax<sup>®</sup>

**Online Report of Army Aircraft Mishaps**

# Preliminary Report on 1<sup>st</sup> Half FY13 aircraft mishaps

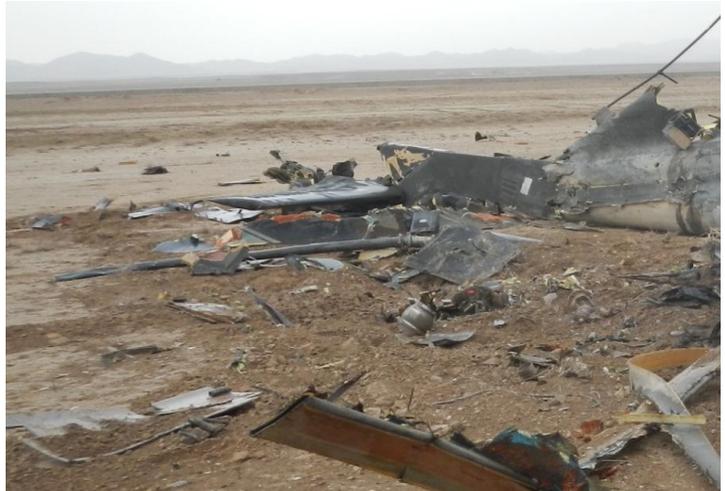
# Mishap Review: NVG RL Training

**While conducting multi-aircraft NVG RL progression training in a low illumination/low contrast environment, the UH-60L entered a right roll and impacted the ground resulting in five crewmember fatalities and a destroyed aircraft.**

The accident board determined that while conducting NVG formation flight as Chalk 2, in a right hand orbit with low illumination and no visible horizon, the crew failed to maintain orientation and lost spatial awareness. The aircraft was placed into an unrecoverable attitude and impacted the ground destroying the aircraft and fatally injuring all five crewmembers. Additionally, the board determined the mission briefing process failed to properly identify and mitigate risk for the flight. The PI, in the conduct of NVG refresher training, was placed beyond experience and readiness level by performing multi-aircraft operations – a mission training task.

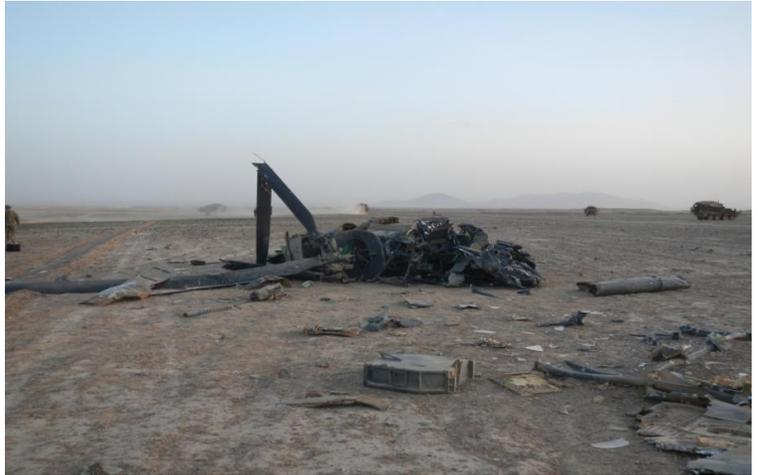
# Mishap Review: OH-58D Engine Failure

While conducting day, multi-aircraft gunnery training the OH-58D experienced an engine malfunction. The aircraft impacted the ground and came to rest on its right side resulting in one crewmember fatality and destruction of the aircraft.

The accident board determined the aircraft experienced an engine malfunction/power loss. Rotor RPM decayed rapidly with accompanying rapid descent and impact with the ground resulting in one crewmember fatality, one critical injury and the aircraft being destroyed. Additionally, the board determined the crew improperly diagnosed/responded to the low rotor RPM indication by not verifying conditions and adjusting the collective immediately to regain rotor RPM.
