# Flightfax

Online Report of Army Aircraft Mishaps

# Mishap Review: UH-60 Ground Taxi

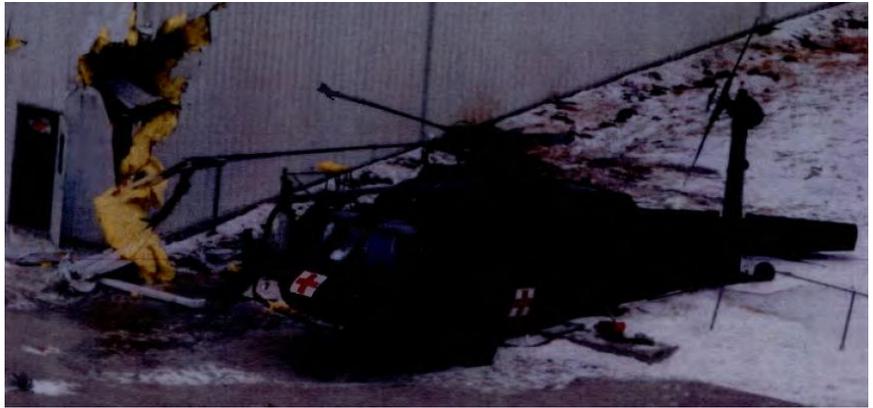
While ground taxiing to a refuel point at a civilian airfield, the UH-60A contacted an aircraft hangar resulting in significant aircraft damage and no injuries to the crew.

The accident board determined the crew failed to maintain a path clear of obstacles allowing the main rotor blades to contact the hangar door. The pilot on the controls failed to estimate distance, closure, and control input; the IP failed to properly direct his attention outside the aircraft during a critical situation; and the co-pilot was not timely and assertive in his obstacle clearance advisories during a critical phase of flight.
