Flightfax®

Online Report of Army Aircraft Mishaps

Mishap Review: NVG Multi-Ship Insertion

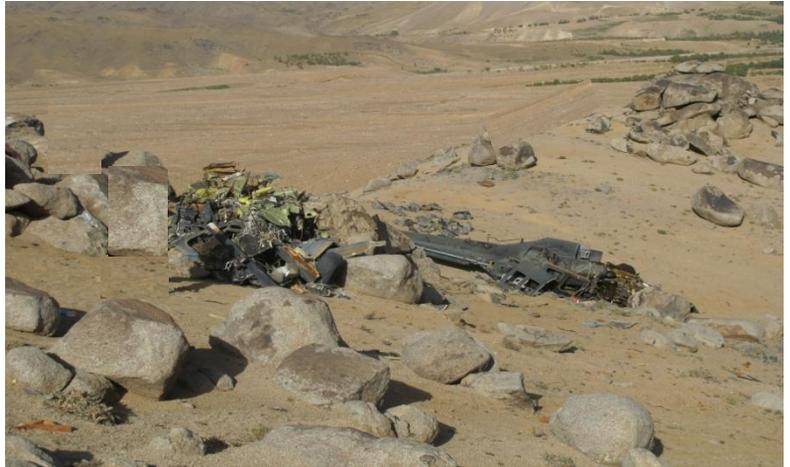
During a multi-ship insertion under NVGs in mountainous terrain, the pilot on the controls placed the aircraft in an excessive nose low attitude while executing a take off from an aborted landing. When power was applied to arrest the rate of descent, the rotor speed bled off and the aircraft struck a rock formation nose first.

The accident board determined that while initiating a takeoff for a go-around, the power demanded exceeded the power available resulting in a decrease in rotor RPM. The aircraft descended and impacted a rock formation. Contributing to the power demand was an excessive nose low attitude on takeoff, requiring additional power that was not available due to environmental conditions. Additionally, the board noted inadequate crew coordination in that over a seven second period the aircraft torque readings increased to max torque available and the pitch attitude lowered to greater than 15 degrees nose low without any verbal or physical reaction from the other crewmembers. After seven seconds, the PC responded verbally, but the crew did not have the power required to recover the aircraft.

Bottom line up front (BLUF). The aircraft crashed because the power demanded exceeded the power available for the environmental conditions causing a decreasing RPM-R (rotor droop) and associated loss of lift.

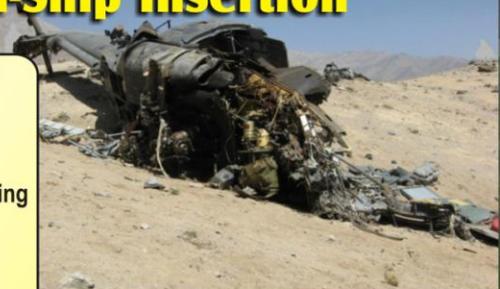
During a multi-ship insertion under NVGs in mountainous terrain, the pilot on the controls placed the aircraft in an excessive nose low attitude while executing a take off from an aborted landing. When power was applied to arrest the rate of descent, the rotor speed bled off and the aircraft struck a rock formation nose first.

While conducting a multi-ship deliberate insertion under NVGs in mountainous terrain, the pilot on the controls aborted the landing attempt. As he was executing the takeoff from a pinnacle at approximately 8,650 MSL, he placed the aircraft in an excessive nose low attitude. When the pilot in command recognized the nose low attitude and increasing rate of descent, he applied power to arrest the descent. The environmental conditions, coupled with the aircraft weight, resulted in the rotor speed bleeding off as the pilot in command increased the collective. As a result, the aircraft was unable to produce the power demanded of it and descended nose first into a rock formation. The cabin area and fuselage were torn from the cockpit upon impact and several passengers were ejected from the aircraft as the fuselage rotated in the air. The fuselage came to rest on its right side approximately 50 meters from the cockpit.

- PI* over-controlled the aircraft
- PC failed to act in a timely and appropriate manner
- Aircrew failed to utilize proper crew coordination

- Train with an emphasis on proper power management flight techniques
- Positive communication within the cockpit & among the entire flight
- Maintain situational awareness at all times

- Emphasize importance of proper power management flight techniques
- Reinforce importance of crew coordination
- Ensure tabular data is utilized for performance planning before and during flight
