Flightfax[®]

Online newsletter of Army aircraft mishap prevention information

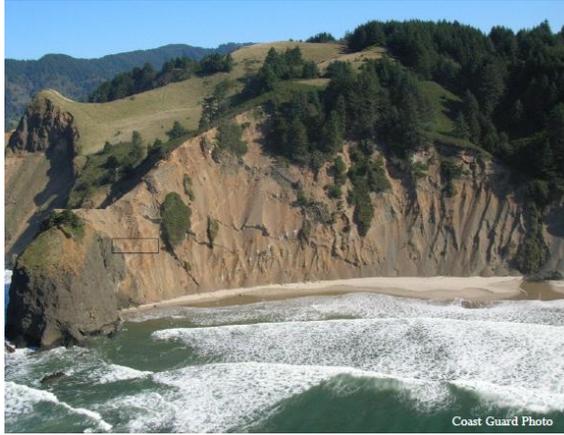
The incident scene. The rectangular box indicates the area in which the victims were trapped.

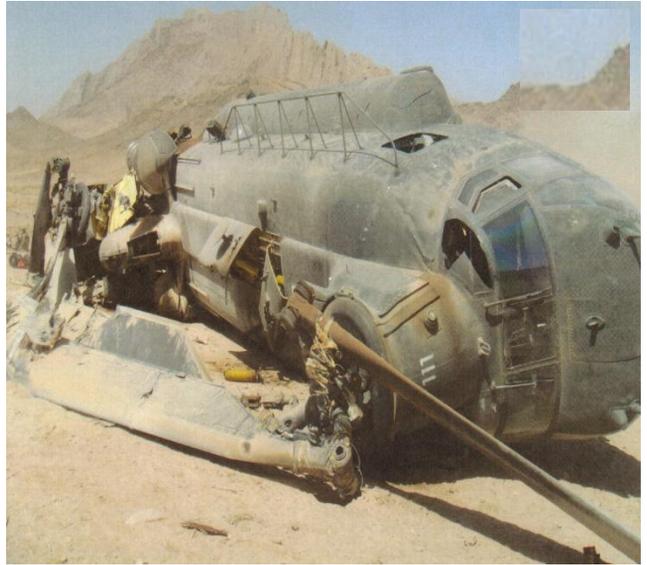
Mishap Review: Multi-ship AASLT

While conducting a Day, multi-ship, air assault landing to an unimproved HLZ, the CH-47D encountered brown-out conditions. The aircraft touched down with a right roll resulting in the main rotor blades striking the ground. The aircraft came to rest on its right side with major damage and only minor injuries to the crew and passengers.

The accident investigation determined that the crew failed to execute a go-around when visual contact with the intended landing area was lost. Additionally, the pilot not on the controls (PC) directed his attention inside the cockpit during a critical phase of landing. Also, during the landing sequence, the passengers removed their restraints prior to the completion of the landing without direction from a member of the crew. As a result, they suffered minor injuries when they were tossed about in the cargo area during the crash sequence. No passenger brief or static-load training had been completed.

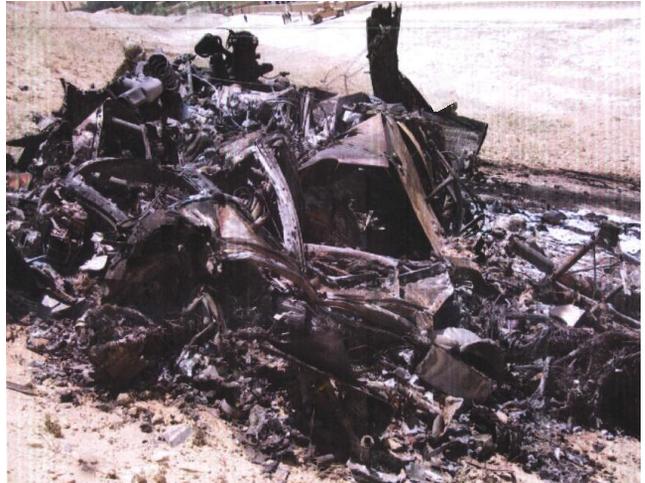
Mishap Review: MEDEVAC Chase

While conducting an NVG landing to an unimproved HLZ under zero illumination conditions, the HH-60L encountered brown-out conditions. While attempting a go-around, the aircraft drifted and impacted rising terrain coming to rest on its right side. A post crash fire destroyed the aircraft and two crewmembers sustained moderate injuries.

The accident board determined the PC on the flight controls, after loss of visual references, failed to correct for drift or adjust heading to avoid known obstacles. It was also noted the pilots were not utilizing the HUD, which might have assisted in maintaining orientation.
