# Flightfax

Online newsletter of Army aircraft mishap prevention information

## AH-64 Safety Performance Review

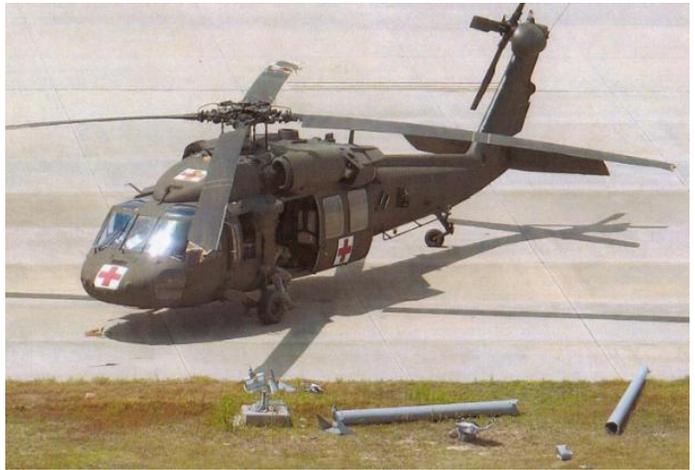
**While ground taxiing to parking at a civilian FBO, the UH-60A's main rotor contacted a 25 foot light pole resulting in significant damage to the aircraft. Chalk 2, two civilian fixed-wing aircraft, and an Air force jet were also damaged by flying debris. There were two injuries to FBO personnel.**

At 1335L the two aircraft landed at a commercial field for refuel with the accident aircraft (Chalk 1) leading into parking at the FBO ramp. While positioning into their parking spot, Chalk 1's main rotor system contacted a 25-foot light pole located on the edge of the parking ramp. The collision severely damaged the accident aircraft main rotor system, drive train and engines. Chalk 2 sustained minor airframe skin damage and FOD to the #1 engine. Flying debris damaged an Air Force jet and two civilian fixed wing aircraft. Injuries occurred to two FBO employees, one an abrasion to the right calf, and the other a broken foot.

The accident investigation determined that while maneuvering to parking, the crew failed to properly scan resulting in failing to detect and avoid the light pole at the edge of the ramp. Additionally, the IP was distracted as he attended to tasks inside the cockpit.
