Flightfax[®]

Online newsletter of Army aircraft mishap prevention information

Black Hawk Safety Performance Review

Mishap Review: Night ground taxi

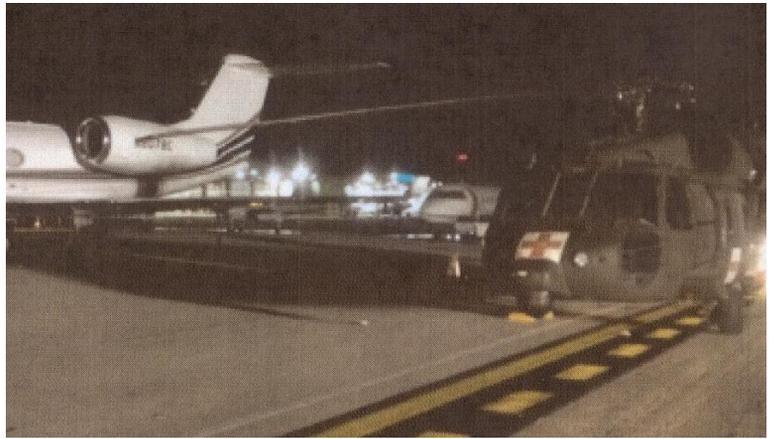
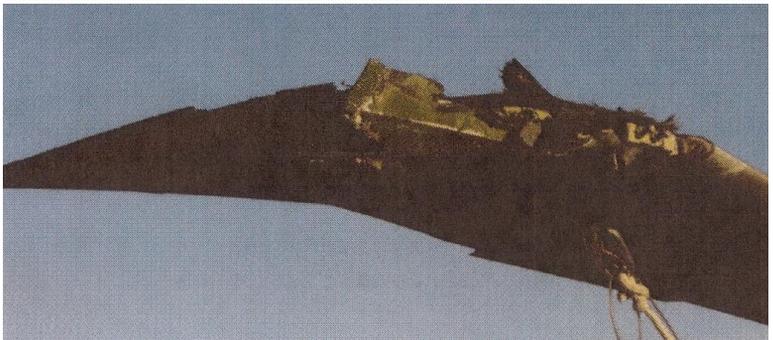
During night ground taxi for departure from a civilian airfield, the HH-60L's four main rotor blades contacted the winglet of a parked Gulfstream aircraft. Major damage occurred to both aircraft. There were no injuries.

Following refuel the crew updated their weather receiving an arrival forecast of a broken ceiling at 500 feet with 2 miles visibility. At approximately 1907L the crew initiated ground taxi for NVG flight home. Three minutes later the main rotor blades contacted the winglet of a parked Gulfstream G450. All four main rotor blades contacted the winglet and the winglet was completely sheared from its fixed position. The crew performed an immediate shutdown.

The accident investigation determined that the crew failed to clear the aircraft and communicate an obstacle that posed a threat to the aircraft. Additionally, the aircraft was not following an established taxi line but was on a non-movement area boundary marker.
