Flightfax[®]

Online newsletter of Army aircraft mishap prevention information

Materiel Related Five Year Accident Review

Mishap Review: AH-64D EP Training

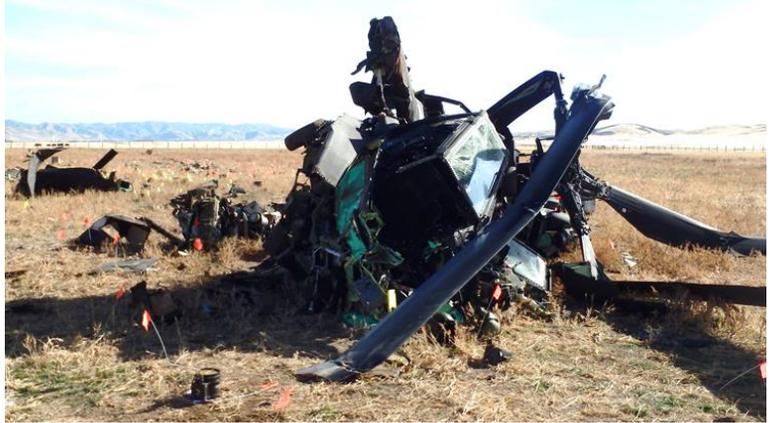
While conducting night, emergency procedures training, the NP speed of both engines increased to the overspeed protection setting resulting in a dual engine shutdown. The aircraft lost rotor RPM and crashed. Both pilots were fatally injured.

The accident investigation determined that during the conduct of the DECU lockout procedure with the #1 engine, the IP had started the maneuver by inadvertently taking the #2 engine out of the fly detent before confirming and then re-directing the procedure to the #1 engine. When the #1 engine was placed in lockout and the #2 engine not being seated in the fly detent, both engines accelerated to the overspeed protection trip point resulting in a dual engine shutdown. Rotor RPM rapidly decayed and the aircraft impacted the ground.
