# Flightfax<sup>®</sup> ISSUE 50

Online newsletter of Army aircraft mishap prevention information

# Mishap Review: MD530F

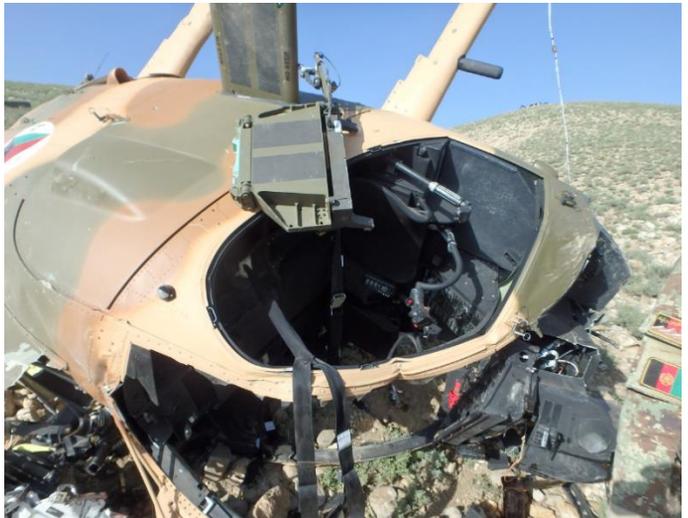
During the conduct of a day VMC approach to an unimproved landing site, the MD530F began an un-commanded right yaw at approximately 15 feet AGL. The aircraft did not respond to the aircrews attempt to control the heading, descended and impacted the ground. The aircraft sustained major damage with no injuries to the crew.

Investigation determined the aircraft would not provide sufficient tail rotor authority during an approach to a hover at the density altitude and weight at which it was operating. The aircraft's flight manual provided only one chart indicating less than 10% control authority at DA greater than 5,000 feet at a heavier gross weight. This fact was not adequately addressed by written warnings or in the limitations section of the flight manual. Additionally, the IP's aircraft qualification training did not teach the performance limits of the aircraft at high gross weights and/or high density altitude.

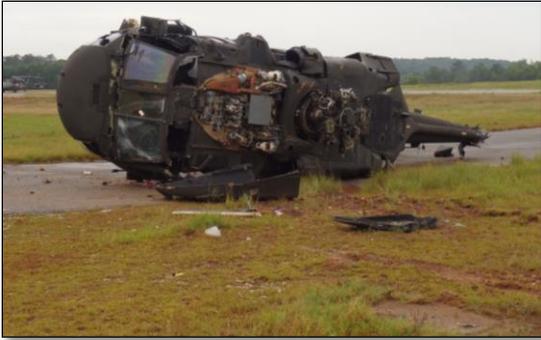
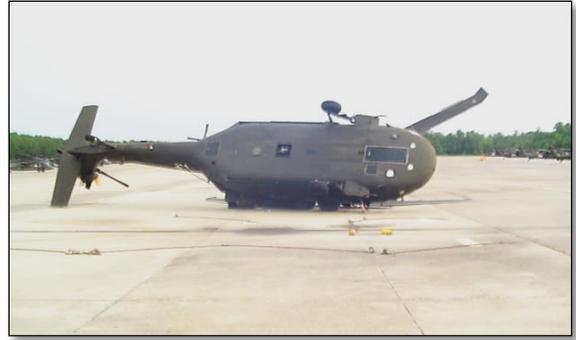
**While hovering to parking, the UH-60L encountered a strong force of wind and rain which induced a sudden left yaw and rapid descent of the aircraft and ground impact. The aircraft was severely damaged with no injuries to the crew.**

While hover taxiing to parking, a 44-knot gust of wind from 340 degrees impacted the left side of the aircraft coupled with an extreme downdraft that impacted the top of the aircraft. The combined force of the wind and rain induced a sudden left yaw and rapid descent of the aircraft. The aircraft pitched down with the main rotor blades striking the ground followed by impact on its right main landing gear with separation of the tail rotor pylon and rolling on its left side. The aircraft was severely damaged with no injuries to the crew. Another unoccupied parked aircraft was rolled on its side during the severe weather.

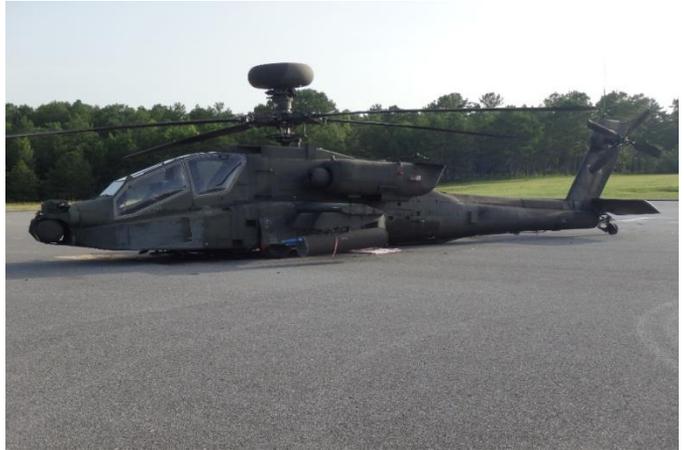
During the conduct of aerial gunnery training, the AH-64D descended rapidly from a climbing high hover and landed hard on the firing pad. The aircraft sustained serious damage. There were no injuries.

Investigation determined the aircraft experienced an engine failure of the No. 2 engine. The aircraft weight and environmental conditions precluded single-engine flight resulting in decreasing rotor RPM and a rapid descent to a hard landing.

The No. 2 engine failure was attributed to a fracture and separation of a compression blade on the stage 2 compressor blade disc. The separated disc resulted in downstream compressor engine object damage, high cycle fatigue to the engine compressor and subsequent, abrupt engine failure with catastrophic internal engine damage.
