maintenance fax

VOL. 2, NO. 8 ■ 29 MAY 1974

mishaps for the period of 16 APR-15 MAY 1974

POP-OFF LID ?

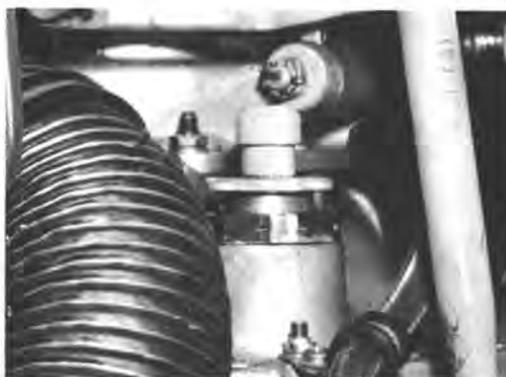
PHOTO 1

Witness marks are aligned and filler cap appears secure (photo 1). However, space between serrated collar and filler flange is greater than width of collar.

Although use of witness marks on transmission oil filler caps is not required, these marks help alert flight crews to a possible unsafe condition and their use is recommended.

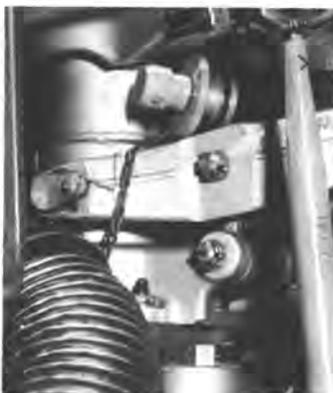
PHOTO 2

During operation, pressure builds up within transmission housing, unseating filler cap, and blowing it into flight controls (photo 2).

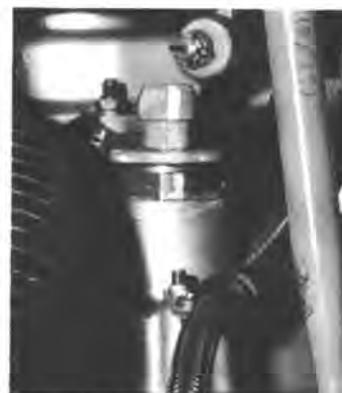
PHOTO 3

When cap is properly seated and secured, space between flange and serrated collar is less than collar width and witness marks are aligned (photo 3).

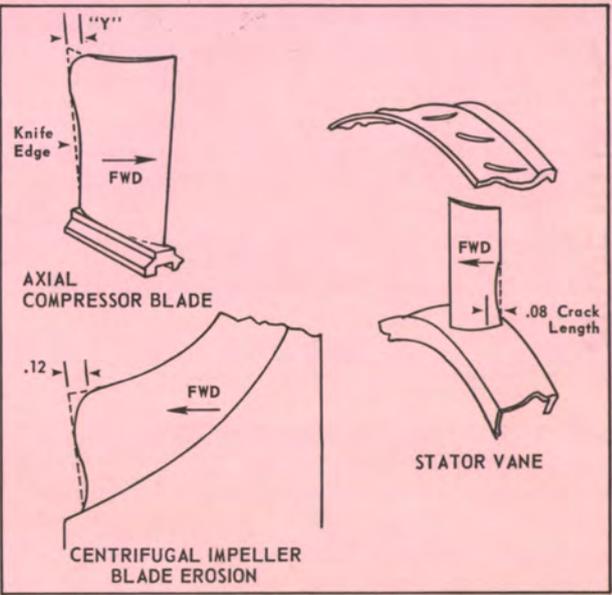
Figure 1

"Certain criteria were established as representative of erosion conditions noted in engines subject to compressor stalls and may be used as guidelines in identifying engines which are candidates for compressor stalls. These criteria, shown in figure 1, should not be considered as no-go indicators in authorizing return of engines to depot.

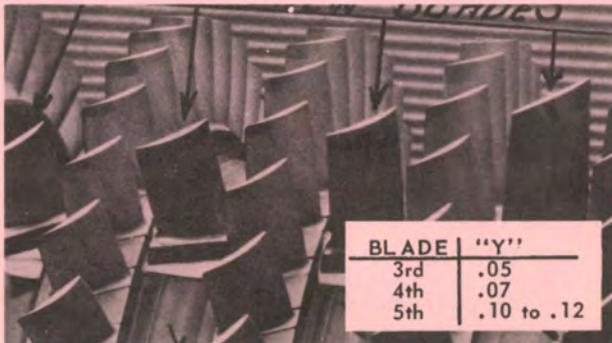
Figure 2

Figures 2 and 3 show an engine taken from an
