ARMY AIRCRAFT MISHAP PREVENTION DATA

FLIGHT FAX

A USAAAVS PUBLICATION
US Army Aviation Training Library

VOL. 3, NO. 1 ■ 9 OCTOBER 1974 Fort Rucker, Alabama 36360 mishaps for the period of 20-26 SEPTEMBER 1974

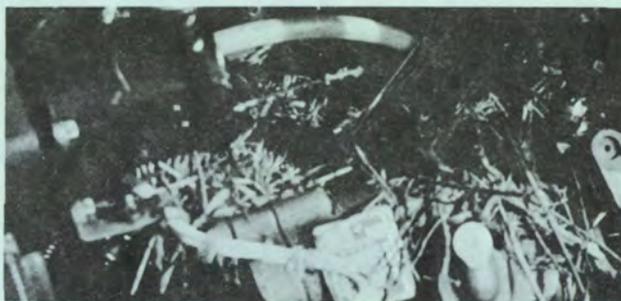
IT'S THAT TIME OF YEAR AGAIN. An alert maintenance man found this bird's nest on the fuel control of an AH-1G engine. The bird apparently entered the cowling at the opening around the exhaust pipe. The aircraft had been parked for two or three days. These nests can be built in a very short time, so be on the lookout.

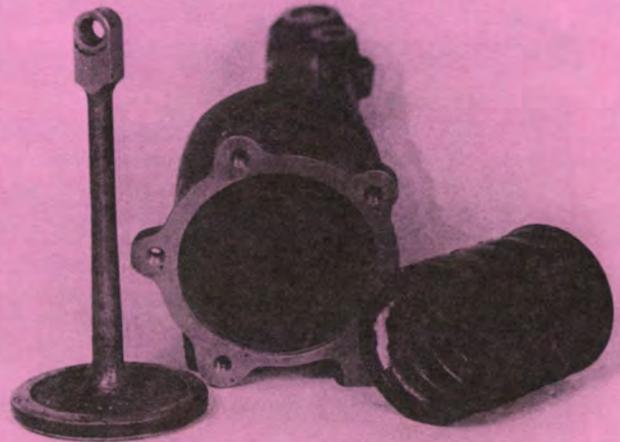
▲ Sticky B&B compound collects on top of piston, holds dirt, and causes piston to bind and score cylinder.

Last but not least, *never* spray anything into a running engine. Spraying of cleaning solvents and water should be done while the engine is being motored with the starter only.

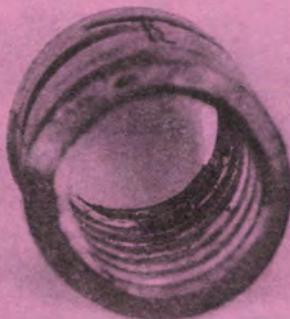
▲ Close-up showing compound and dirt collected inside return spring and cylinder. ▶

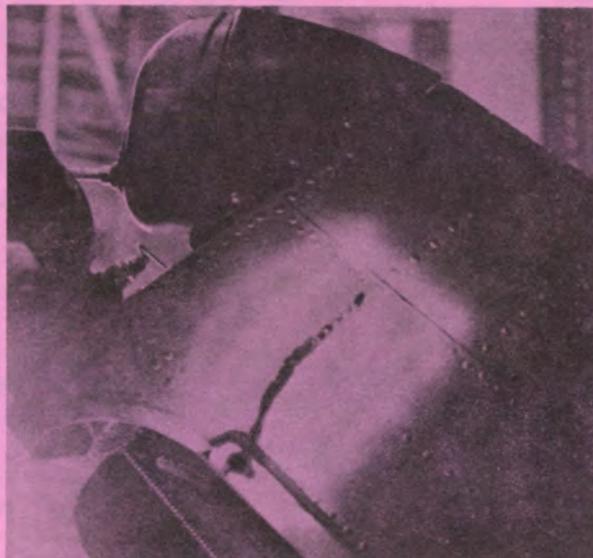
Dark location surrounding crack is the dye penetrant used to define location of crack. Drawn-in ink line represents location of crack itself.

e. "Inspect vertical fin rib (P/N 204-030-827 or P/N 204-031-098) along rivet row at fin station 10.08, L/H side, for cracks. Inspection to be accomplished through topmost lightning hole of the vertical fin forward spar with a flashlight and inspection mirror." This new inspection shall be performed at periodic for TM 55-1520-210-PMS sequence No. 6.2.3; TM 55-1520-219-PMS sequence No. 6.1.3; TM 55-1520-220-PMS sequence No. 6.1.5.

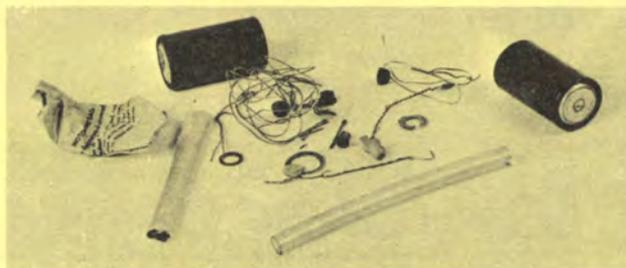
During a recent safety survey team inspection at one airfield, these foreign objects were picked up from the ramp and helipads where helicopters were in operation.

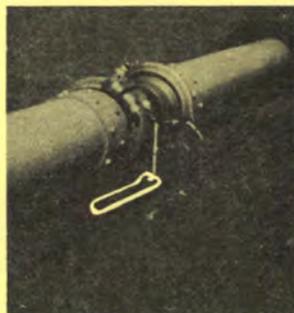
During preflight inspection, a 1/4-inch wrench was found lodged underneath the base of the No. 4 hanger bearing. Rust had formed under the wrench. The aircraft had been out of PE for 3 weeks and had been flown 5 hours. Damage was small—minor scratches—but the oversight could have resulted in fatalities and the destruction of the aircraft.

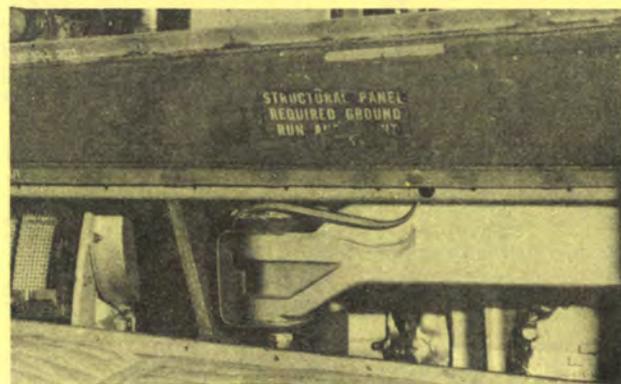
A UH-1H crew chief was inspecting his helicopter when he noticed something wedged between the main transmission and side structural panel. Removal of the panel revealed this damage. It is suspected the cotter key extractor was dropped into the transmission well while work was being done in the area of the main rotor hub assembly 25-30 hours before its discovery. Damage resulted in replacement of the main transmission. Evidently, no toolbox inventory was made.
