FLIGHT FAX

A USAAAVS PUBLICATION

VOL. 4, NO. 1 ■ 8 OCTOBER 1975

mishaps for the period of 19-25 SEPTEMBER 1975

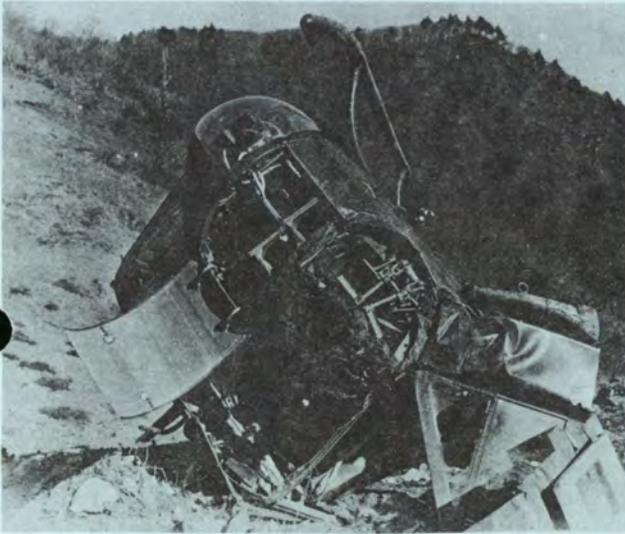
This photo shows what was left of a Huey that came to grief on a quick reaction air mobile operation. The mission was a dropoff of troops near the top of a mountain. The pilot selected a sloping area on the downwind side and, since there was no level ground available, intended to discharge the troops at a hover. The approach was to the north, with wind from the west. The approach was terminated at a hover and rpm started falling. An attempted left pedal turn caused further loss of rpm. Attempts to regain rpm were unsuccessful and the tail rotor struck the ground. The tail boom broke off, the fuselage struck and bounced, the main rotor struck the ground, and the helicopter turned over. Some of the troops were thrown out and one was injured by a main rotor blade.

The cause of this accident was the crosswind approach on the downwind side of the mountain, with the left pedal turn contributing to the loss of rotor rpm. Fatigue was considered a possible factor because the pilot was living under field conditions that were less than ideal. On this mission he didn't even have a rated copilot. There was no clear indication that loss of engine power contributed to

the accident, but fuel in the aircraft was found to be contaminated.

■ For pilots: The necessity for close evaluation of every situation, to include aircraft load, wind, elevation, and terrain, and the need to monitor every approach all the way down and stay ready to take corrective action.

■ For unit commanders and supervisors: The essentiality of close supervision in such activities as aircraft servicing; the importance of good unit operational SOP's that insure, among other things, that passengers stay buckled in until it is time to get out; the need for a good look at the requirement for a flight, versus the criticality of operating conditions, if a complete and fully qualified aircraft crew is not available.

■ For commanders and staff officers at higher levels: The need for planning and organization in an operation to insure good operating procedures, adequate logistical support, and living conditions that provide opportunity for sufficient rest. This last is a necessity for personnel operating sophisticated equipment under critical conditions.

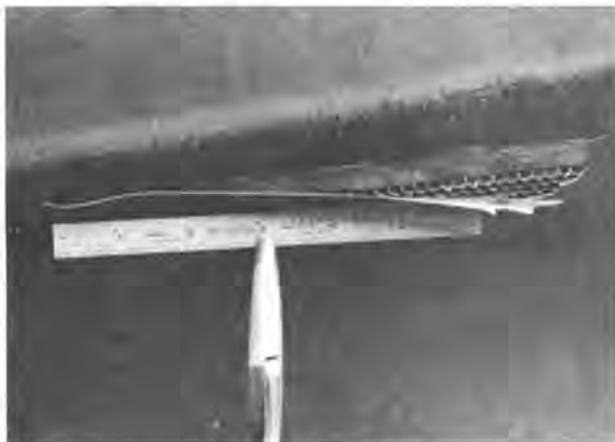
This photo of a UH-1 main rotor blade shows what can happen to an aircraft flying at 2,000 feet and 90 knots when a severe vertical vibration develops. This situation may be avoided, however, if the above inspection is accomplished daily.

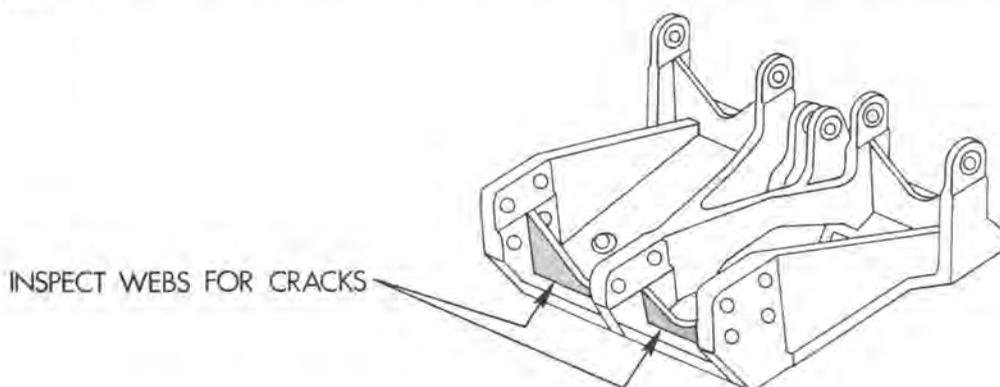
for cracks. All cracks reported in the support assembly have originated in the top edge of the forward web (see illustration). If a crack is found, remove and replace the support assembly, notify AVSCOM, and submit an EIR.

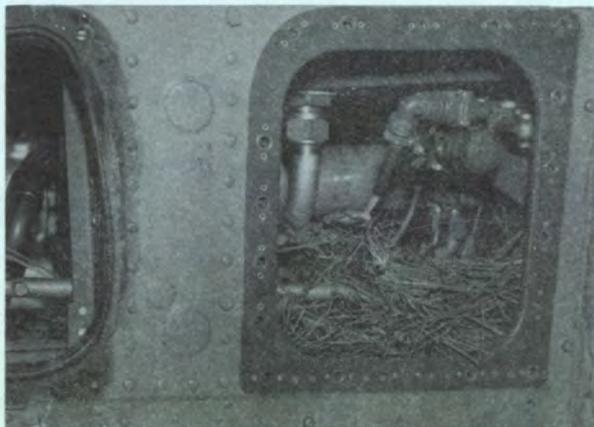
This bird nest was discovered in the lower pylon area of a UH-1H during a periodic inspection in October when the access panel was removed. The aircraft had been flown 100 hours since the last periodic inspection, which was in March. It is suspected the nest was constructed during the spring nesting period at some time when the aircraft was not operated daily. The degree of chafing of the tail rotor drive shaft indicated the aircraft had operated a good portion of the 100-hour period with the nest so located. It's that time of year again, so be on the lookout.

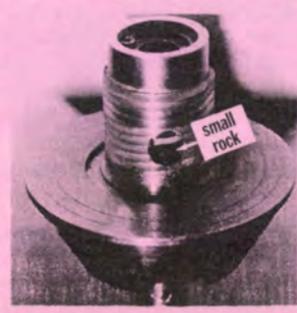
As a fuel sample was being taken from the forward fuel cell of an AH-1G, the sump drain valve stuck in the open position. The fire department was immediately notified, the battery was disconnected, and the aircraft was grounded. A POL truck was used for defueling.

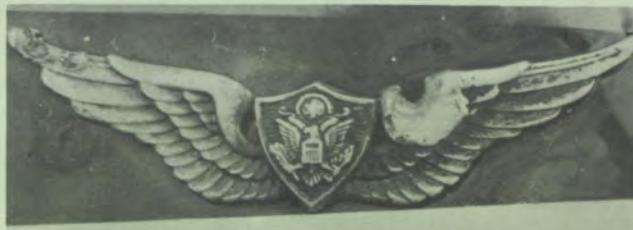
A crew chief was reaching into the battery compartment of a UH-1 to remove a piece of safety wire when his wings touched the battery terminals, causing a shorting condition.
