FLIGHT FAX

A USAAAVS PUBLICATION

VOL. 5, NO. 1 ■ 6 OCTOBER 1976

U.S. ARMY AGENCY FOR AVIATION SAFETY
 FORT RUCKER, ALABAMA 36362

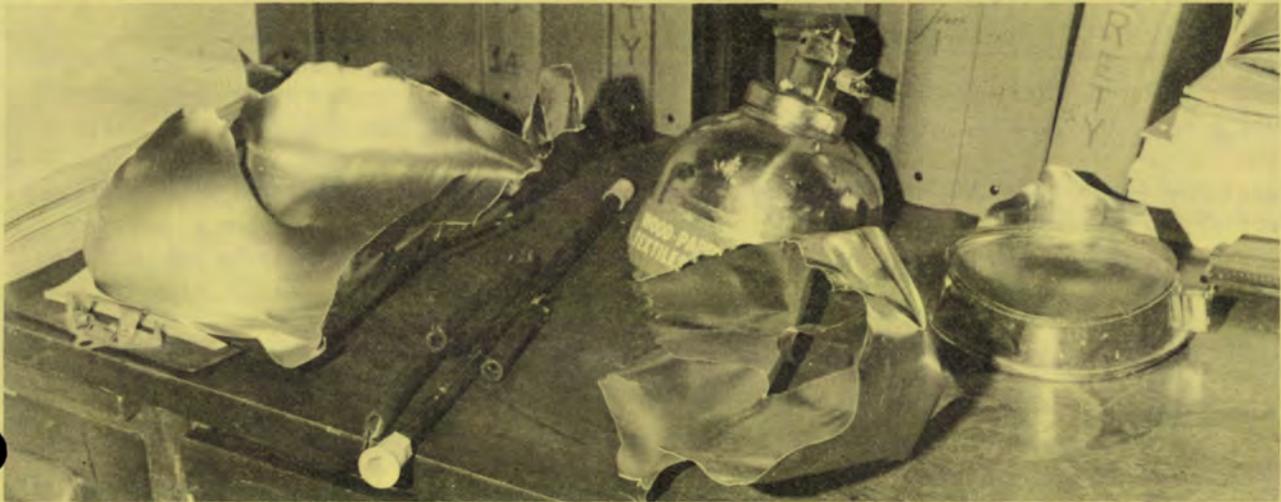
IMPROPER USE OF FIRE EXTINGUISHER

A fire extinguisher (NSN 4210-00-720-1815) half filled with solvent exploded as two crew chiefs were attempting to charge the extinguisher with air. A power-driven compressor, NSN 4310-00-878-7969, was being used for charging. The compressor is designed to supply up to 3,000 psi, while the extinguisher is only tested to 500 psi with a normal charge of 100 psi for use. One individual was monitoring the fire extinguisher gauge while the other was operating the compressor valve. The extinguisher gauge apparently malfunctioned as the needle did not move from the recharge area before the explosion. The extinguisher body exploded into four major pieces and the hose into three.

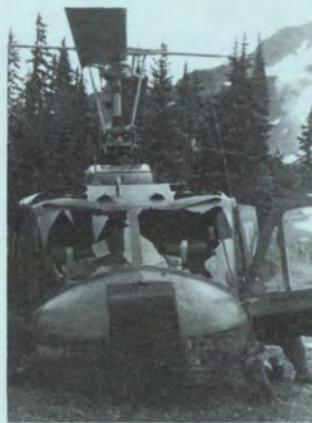
\$95,000 COTTER PIN

The nut backed off the drive shaft and jammed against the sprocket guard, causing the control pedals to stick.

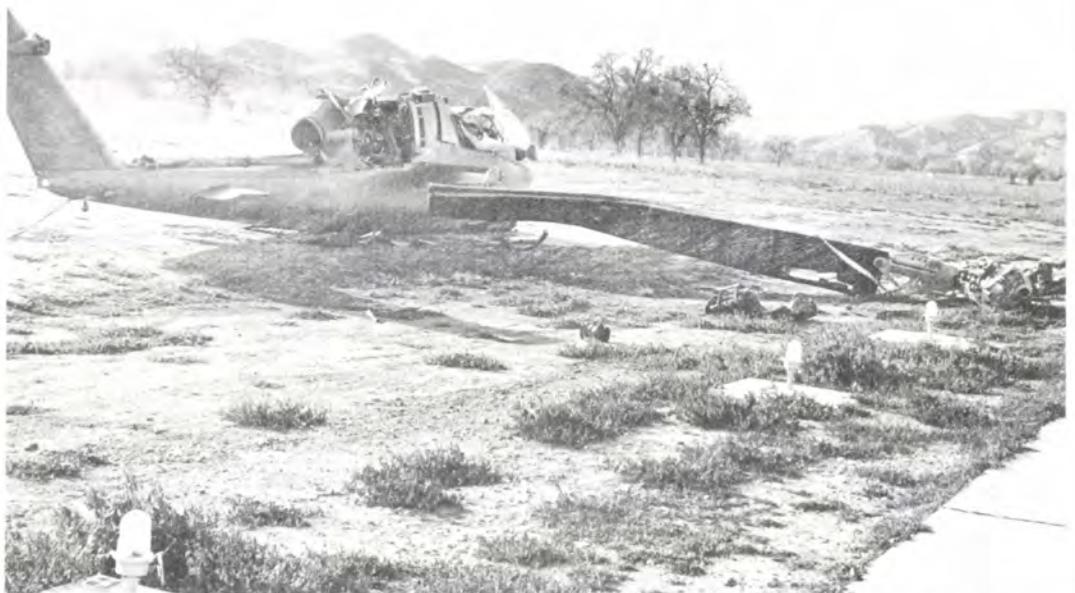
Crew was performing a hover check in this AH-1G when pilot initiated left pedal turn. Ninety degrees into turn, the rate of turn increased violently and pilot applied full right pedal with no apparent response. Aircraft completed three 360° turns and crashed. Suspect the tail rotor silent chain failed and the left pitch setting in the tail rotor blades remained fixed, causing the aircraft to spin uncontrollably to the left. This Cobra was equipped with a 212 tail rotor.

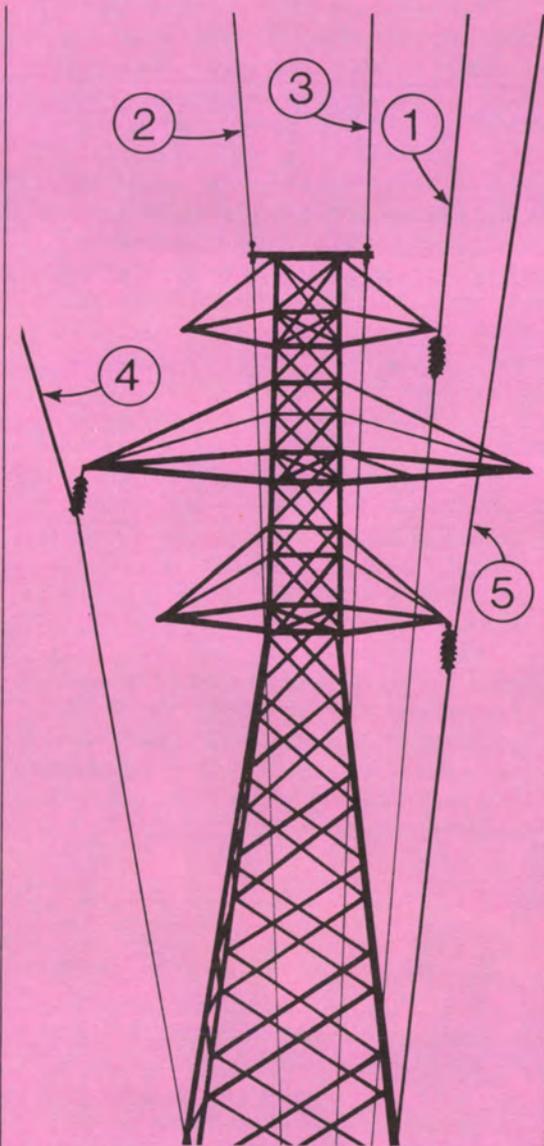
Closeup of tower supporting the wire that was hit (1). Distance from (2) to (1) at the pole is 6 feet. From (1) to (4) is approximately 15 feet. Due to the large span between towers the wires had enough sag to allow the aircraft to pass below wires (2) and (3) and above (4) and (5).

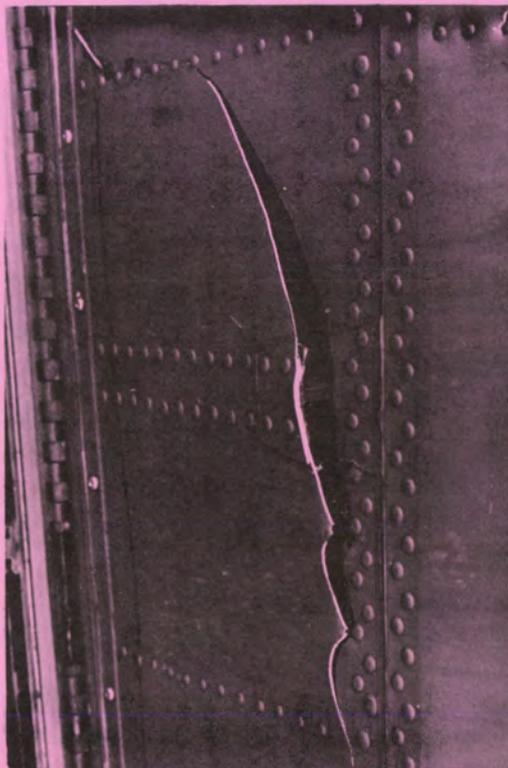
Closeup of sheared fuselage due to tank overpressure.

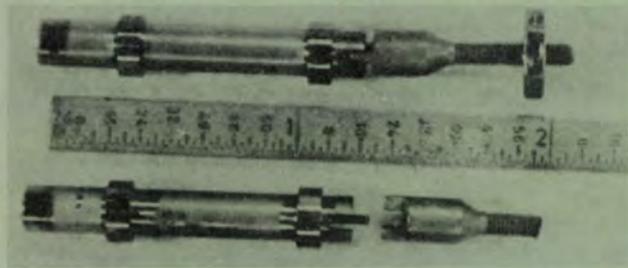
Failure of this P1 multiplier valve connector caused this.

Since 1971, 12 T53-L-13B-powered helicopters have had P1 multiplier connector failures. Six of these resulted in accidents. Emergency procedures for low side governor failure, where altitude and time were available, would have given the pilot power for a controlled safe landing.
