FlightFax

REPORT of ARMY AIRCRAFT ACCIDENTS

October 1994 ♦ Vol 23 ♦ No 1

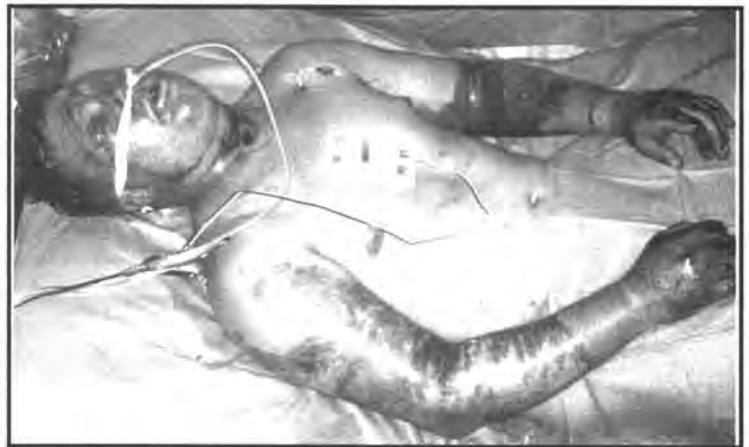
Unharmed skin protected by cotton underwear contrasts sharply with burns on CW3 Tackett's face, arms, and hands.

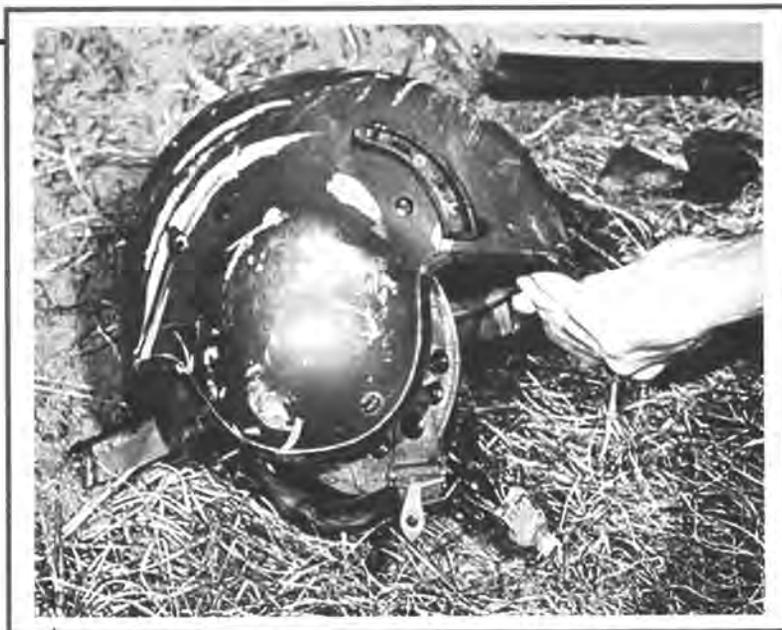
▲ ANOTHER SAVE FOR THE SPH-4 flight helmet!
... FOLLOWING HYDRAULICS-OFF RUNNING LANDING, AIRCRAFT ROLLED OVER,
... PINNING IP IN WRECKAGE. HIS HEAD WAS PROTECTED BY HIS HELMET.

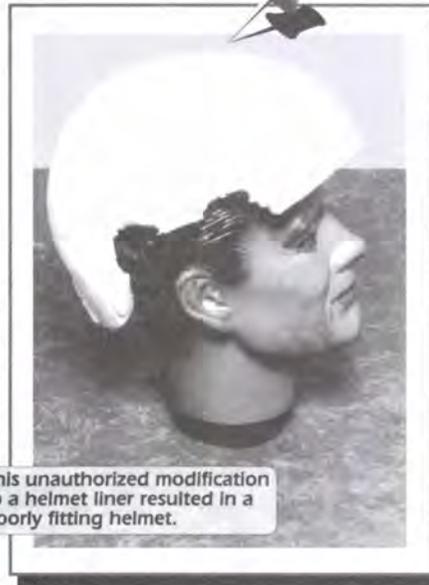
This unauthorized modification to a helmet liner resulted in a poorly fitting helmet.

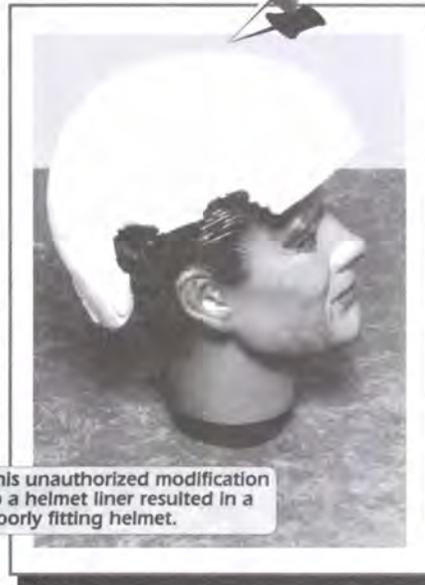
This unauthorized modification to a helmet liner resulted in a poorly fitting helmet.
