Combined Joint Task Force One Safety Alert 12-013 20 Nov 12

On 13 November 2012 a Regional Command – South Soldier was fatally injured and two additional Soldiers received severe injuries due to an explosion while conducting a RIP/TOA inventory. The incident occurred in an ARMAG and preliminary information indicates non-standard storage and handling practices, excessive ammunition and exceeding the NEW for the site license and encroachment issues. The explosion scattered ammunition and explosives over the entire FOB and the ensuing fire spread to an adjoining transient tent.

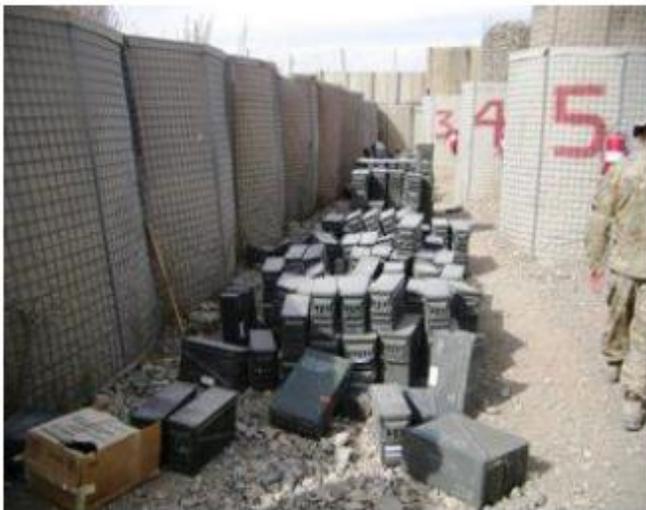
A&E in excess of storage capability

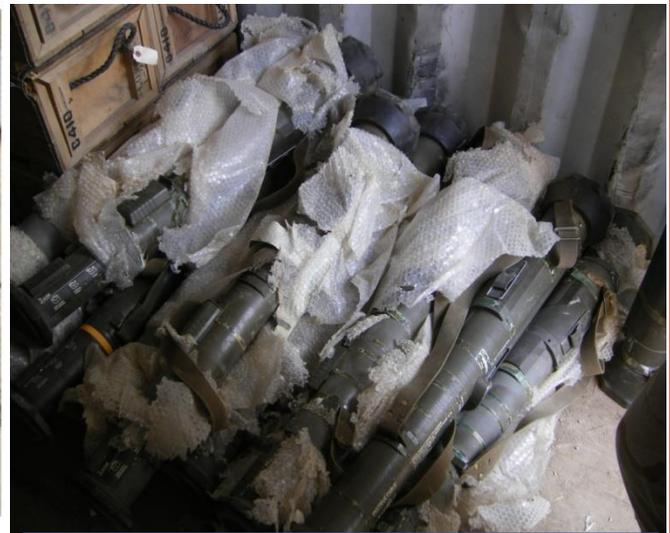
AT-4 Not Properly Packaged
