Flightfax

ARMY AVIATION
RISK-MANAGEMENT
INFORMATION

OCTOBER 1998 ♦ VOL 26 ♦ NO 13

Spotlight: OH-58D safety performance review

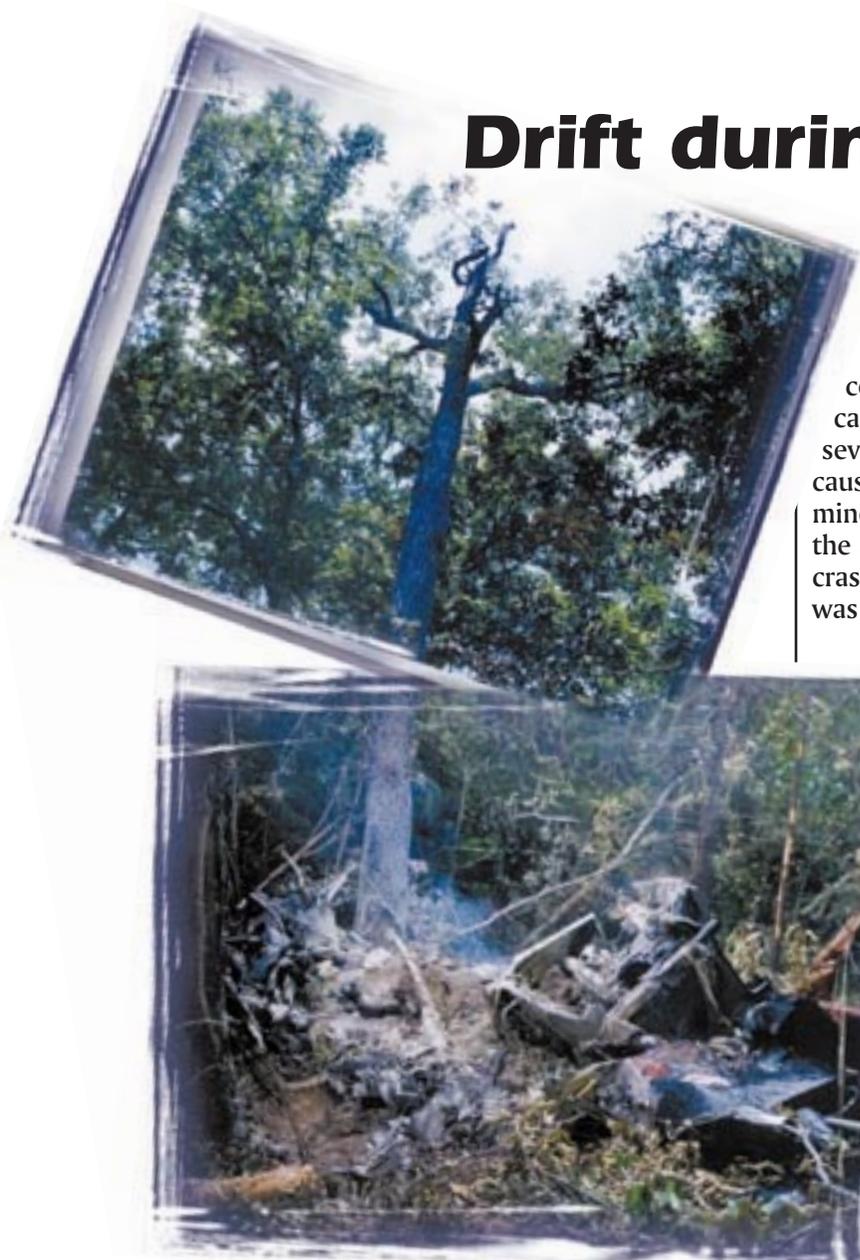
Drift during hover results in tree strike

control through the trees until impact. The aircraft came to rest in a right-side-low attitude, and a severed fuel line in the engine area immediately caused a postcrash fire. The PI had received only minor injuries and was able to extract himself from the aircraft. The IP, however, was killed during the crash sequence; the PI got him out before the aircraft was destroyed by fire.

Lack of situational awareness played a major role in this accident. At the critical moment when the aircraft was closest to the obstacles, the IP's attention became diverted. Why? We'll never know for sure; that question only raises other questions, among them the following:

The tail rotor and vertical fin assembly separated, and the aircraft began a right spin, descending out of

Crew coordination is, as always, a key ingredient in accident prevention. This crew functioned well and planned properly. Extensive mission briefings and rehearsals had been conducted before the mission, and, though not battle rostered, the crew had flown several missions together and were confident that each knew his responsibilities during the flight. However, as this accident proves again, the pilot on the controls must maintain awareness regarding the position of the aircraft and the location of all obstacles.
