Flightfax®

Online newsletter of Army aircraft mishap prevention information

Mishap Review: The day the music died

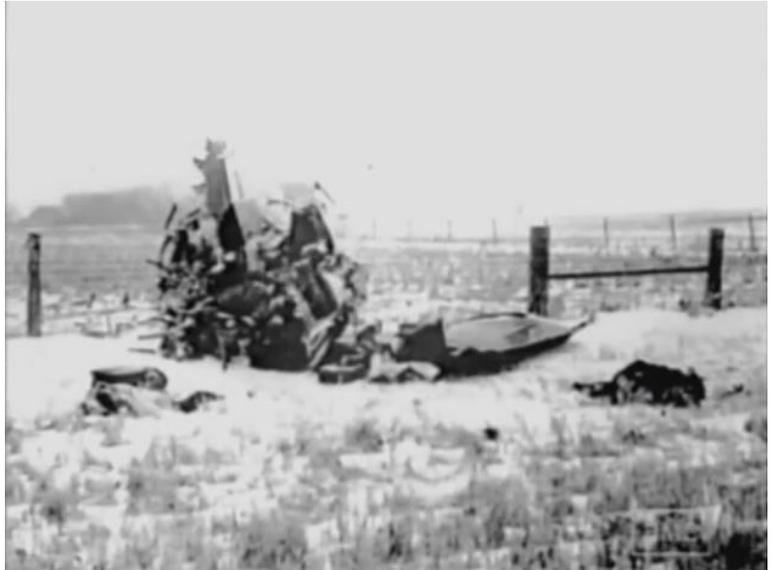
A Beech Bonanza crashed at night approximately 5 miles northwest of the Mason City Municipal Airport, Mason City, Iowa, at approximately 0100 hrs, February 3, 1959. The pilot and three passengers were killed and the aircraft was demolished.

The board determined that the probable cause of this accident was the pilot's unwise decision to embark on a flight which would necessitate flying solely by instruments when he was not properly certificated or qualified to do so. Contributing factors were serious deficiencies in the weather briefing, and the pilot's unfamiliarity with the instrument which determines the attitude of the aircraft.
