Flightfax

ARMY AVIATION RISK-MANAGEMENT INFORMATION

OCTOBER 2002 ✦ VOL 30 ✦ NO 10

FLYING BLIND in a cloud of DUST

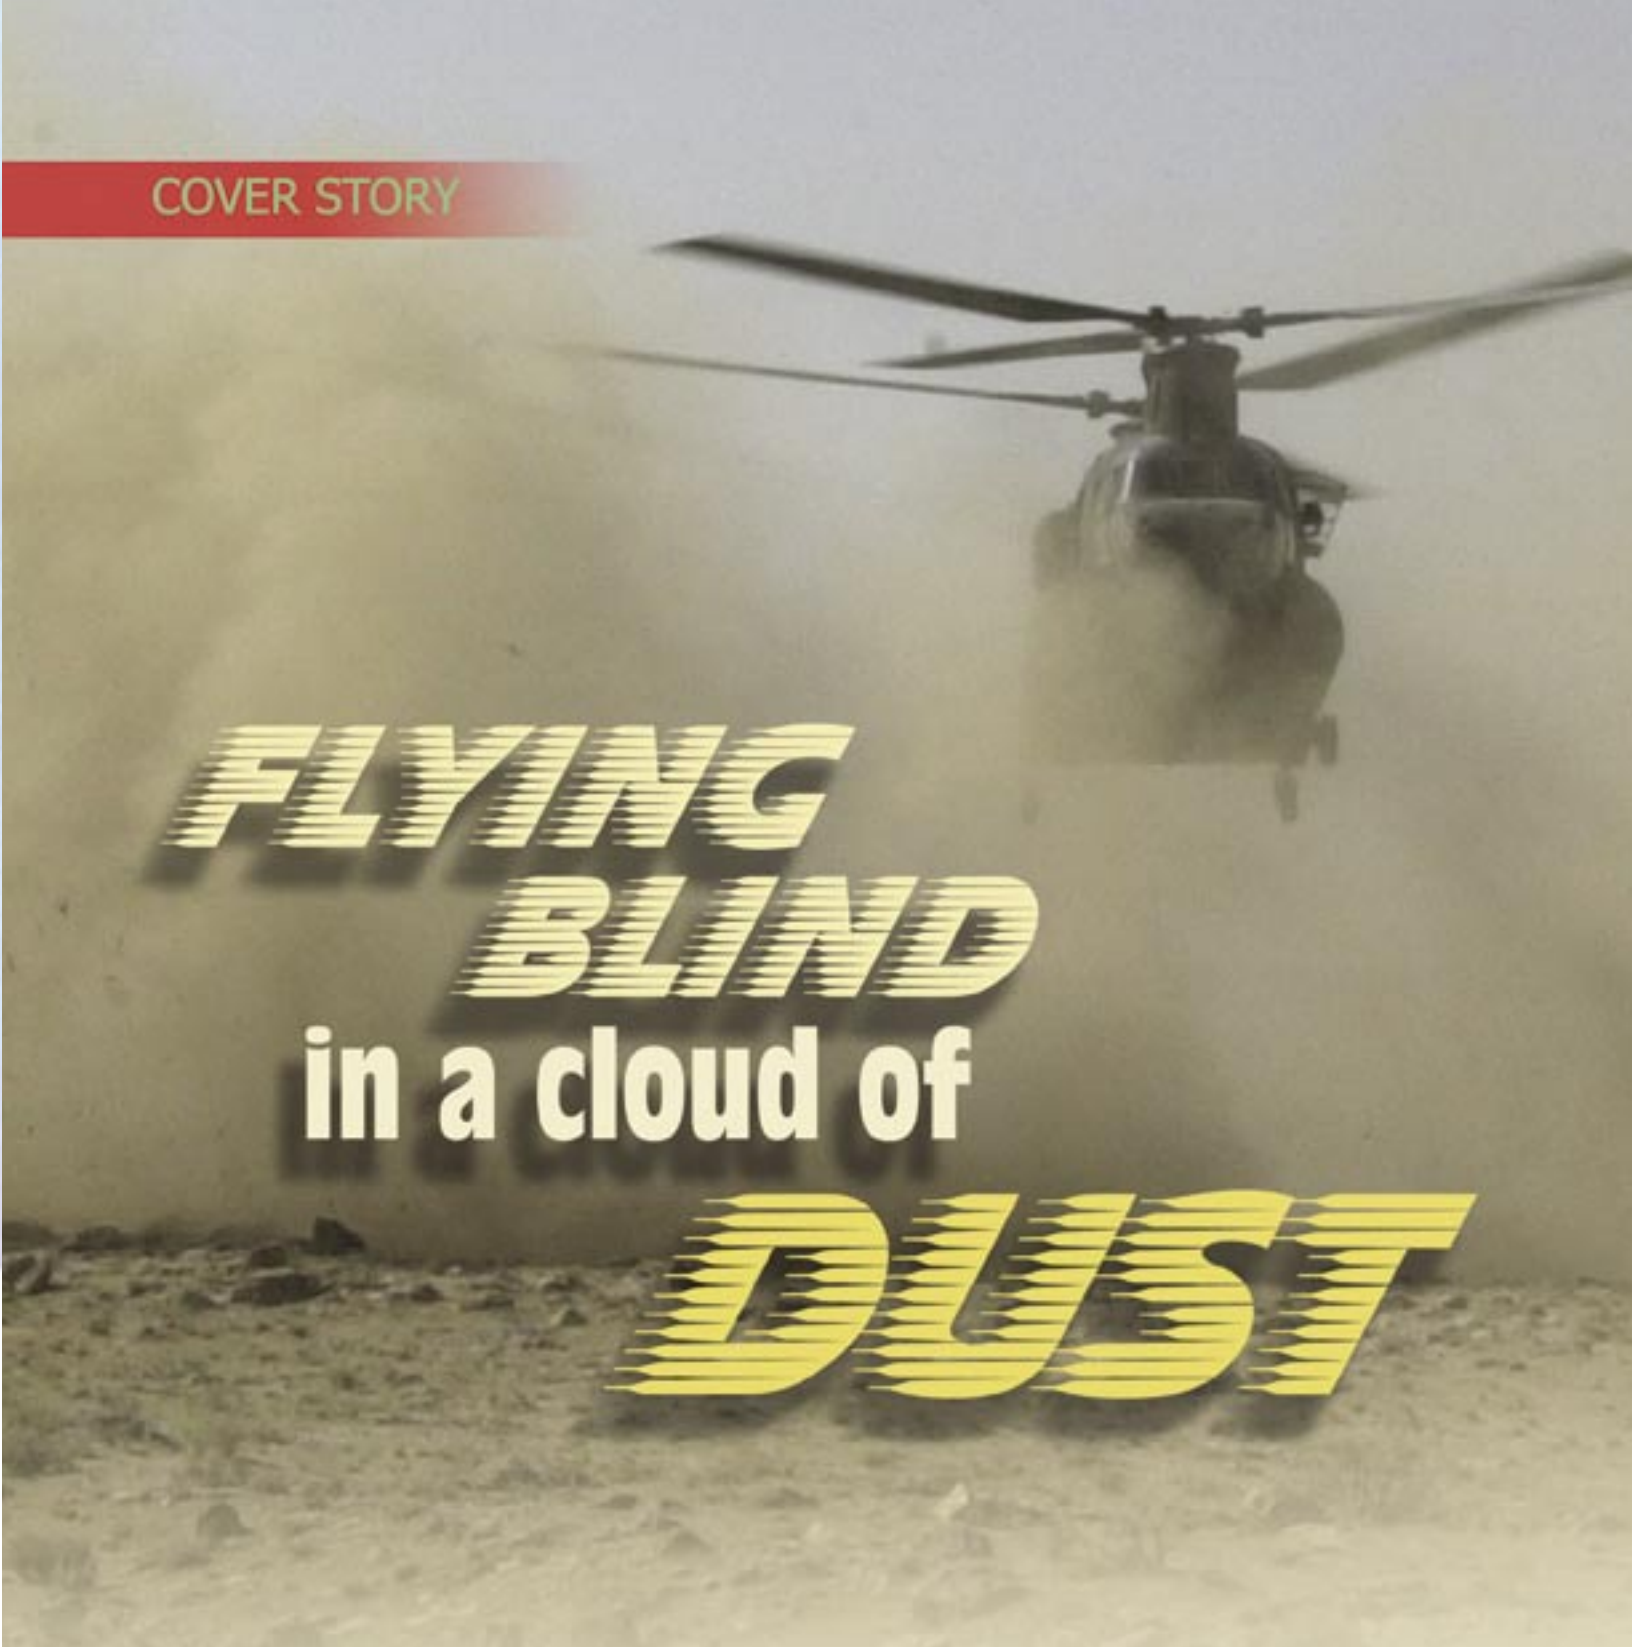
FLYING BLIND in a cloud of DUST

While accidents caused by brownout aren't the biggest problem that aviators face, you can just about count on there being at least one or two Class A or B accidents every year. And that doesn't count the Class C, D, and Es that result from encounters with blowing dust.

The PC had experience flying in both dust and snow, and he knew the area from which he was taking off was dusty—but he didn't expect a brownout. When he took off, he applied forward cyclic instead of using collective to establish a climb, which would have allowed him to fly out of the brownout conditions.

When it became apparent that the ground roll was excessive and the aircraft was nose low (indicating a downslope), the PC refocused his attention toward the front. Seeing the aircraft's refueling boom pass closely over the berm, the PC took the controls and initiated a go-around. The maneuver was too late to prevent striking the berm and causing nearly $400,000 in damage to the aircraft's underside, lower antenna, and chin-mounted FLIR turret.

■ Be sure you are familiar with the procedures in your aircraft operator's manual and the instructions in FM 1-202, *Environmental Flight*, for operating in these conditions.

■ Treat each mission as if it were your first. Familiarity with an area and overconfidence in ability to operate in dusty conditions have led many an experienced aviator to be a little less vigilant, a little less cautious...and suddenly, he's flying blind in a cloud of dust. ■

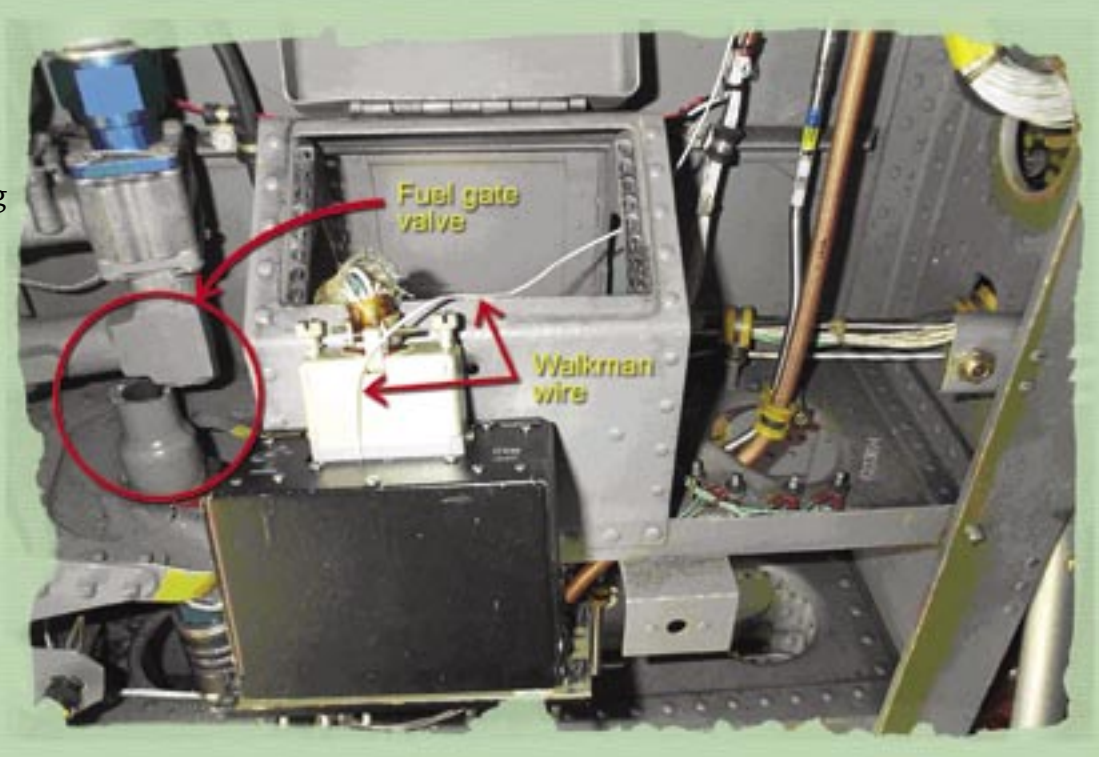
The investigation revealed an unauthorized "Walkman" radio-type modification to the accident aircraft's wiring and aft intercommunications system (ICS) box. While it seems like a harmless modification, listening to music during flight operations may impede mission success.

This unapproved modification allowed the crewmembers to hook up a CD player, radio, or cassette tape player to the #4 HF radio volume control knob and listen to music during missions. While seemingly a harmless modification, listening to music during flight operations may impede critical radio transmissions, ATC clearances, or crewmember-to-crewmember communications during critical flight phases such as clearing the aircraft from obstacles.

Additionally, the unauthorized installation could have allowed stray voltage from the ICS box to ignite fuel vapors when the #1 engine fuel gate valve broke during the accident sequence. The Board could not determine if the modification affected (reduced) the overall volume level of the ICS. The ICS box and wiring installation is being sent to CCAD for teardown analysis, volume testing, and stray voltage analysis. ■

The general WARNING page of TM 55-1520-240-10(a) states: "No electrical/electronic devices of any sort, other than those described in this manual or appropriated Airworthiness Release and approved by AMCOM, are to be operated by crewmembers or passengers during operation of this helicopter."
