Flightfax

ARMY AVIATION RISK-MANAGEMENT INFORMATION

SEPTEMBER 2001 ✦ VOL 29 ✦ NO 9

Flying in bad weather is high risk

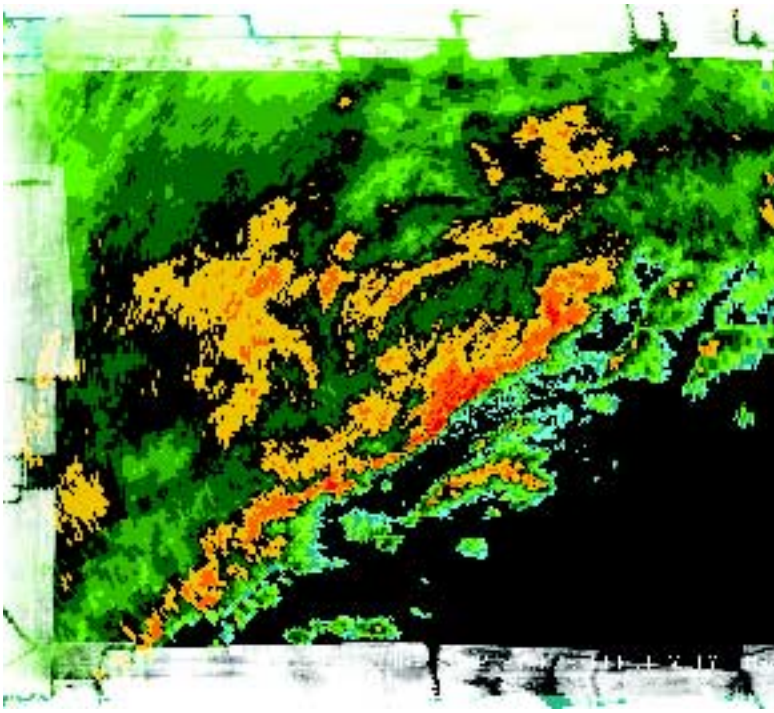
Figure 2. Severe thunderstorm advisory

The crew departed the training site, and a few minutes later, air traffic control (ATC) had the aircraft under positive radar control at 9,000 feet. ATC then advised their traffic of Convective SIGMET 11E (See Figure 2). The advisory stated that there was a line of severe thunderstorms moving from 280 degrees at 30 knots with tops at 40,000 feet. Hail to 1 inch and wind gusts

to 60 knots were also possible. A convective SIGMET implies severe to extreme turbulence, severe icing, and the potential for microbursts and windshear. Traffic was further instructed by ATC to contact flight service or monitor HIWAS (Hazardous Weather In-flight Advisory Service) for the details of the advisory. The C-23 crew did not contact any flight service station for more information on Convective SIGMET 11E. (It is not known if the crew monitored HIWAS on any VOR in their vicinity.)

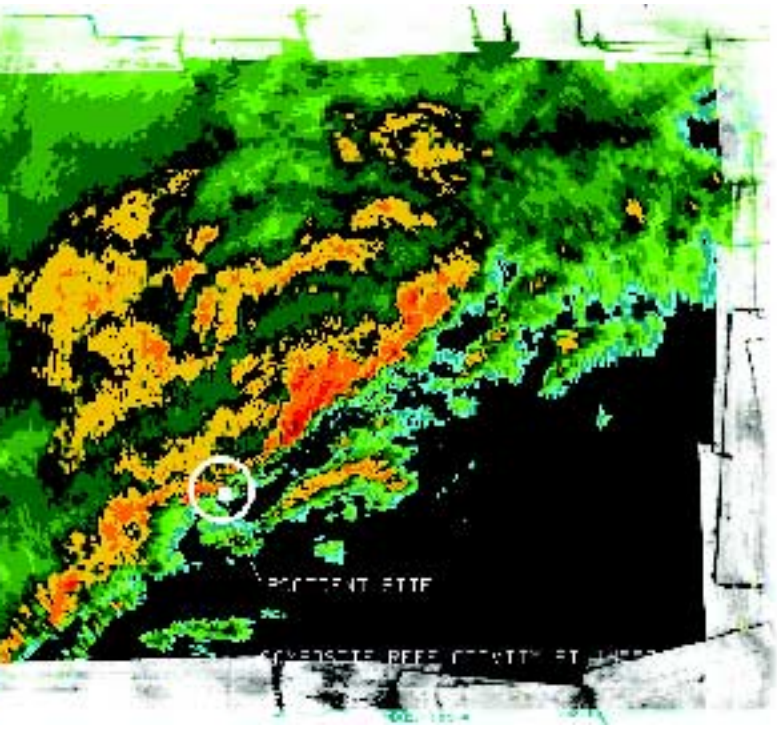
Figure 3. Aircraft broke apart before impact

The crew had encountered extreme turbulence and upper level wind shear in the vicinity of a severe and violently developing level 4 to 5 thunderstorm. The crew lost control of the aircraft, the aircraft experienced loads beyond its design limits, and it broke apart in-flight before impacting the ground.
