ARMY AIRCRAFT MISHAP PREVENTION DATA

FLIGHT FAX

A USAAAVS PUBLICATION
US Army Aviation Training Library

VOL. 3, NO. 1 ■ 9 OCTOBER 1974 Fort Rucker, Alabama 36360 mishaps for the period of 20-26 SEPTEMBER 1974

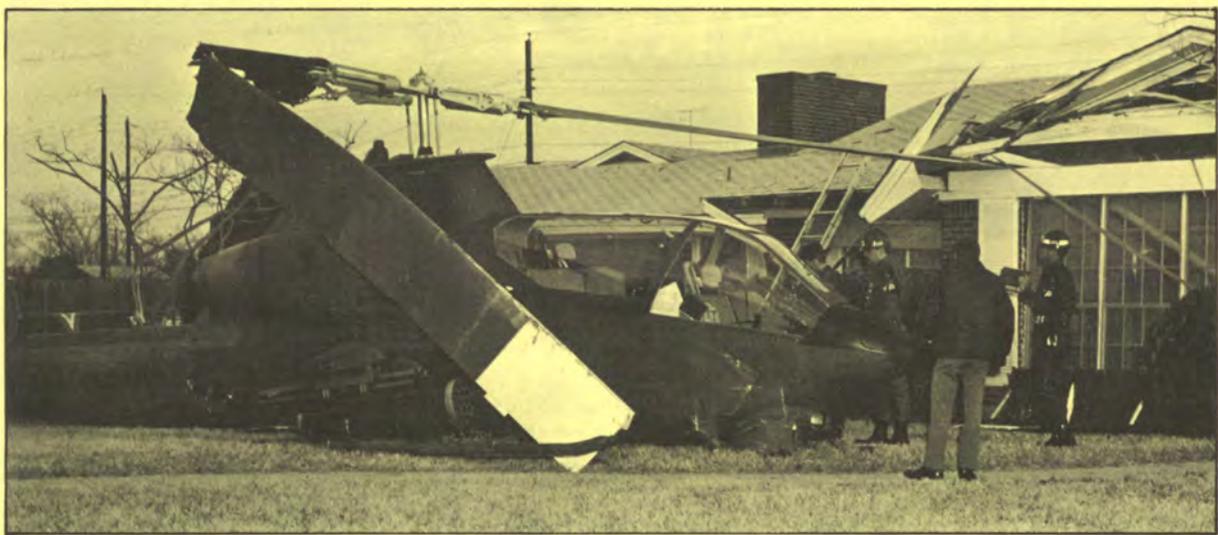
PREFLIGHT WITHOUT LIGHT

After washing, the engine and transmission cowlings were left open to permit the aircraft to dry. A crew chief, one of the last to leave the

This accident once again proves the necessity for thorough preflights. The pilot in command and the copilot failed to perform a

proper preflight inspection of the aircraft during the hours of darkness, thus insuring that all cowlings and latches were secured. Reason: The pilot felt that the preflight performed late in the afternoon on the previous day would suffice and that a walk-around inspection—conducted without a flashlight—the next morning was all that was required. The copilot did not assist in the preflight.

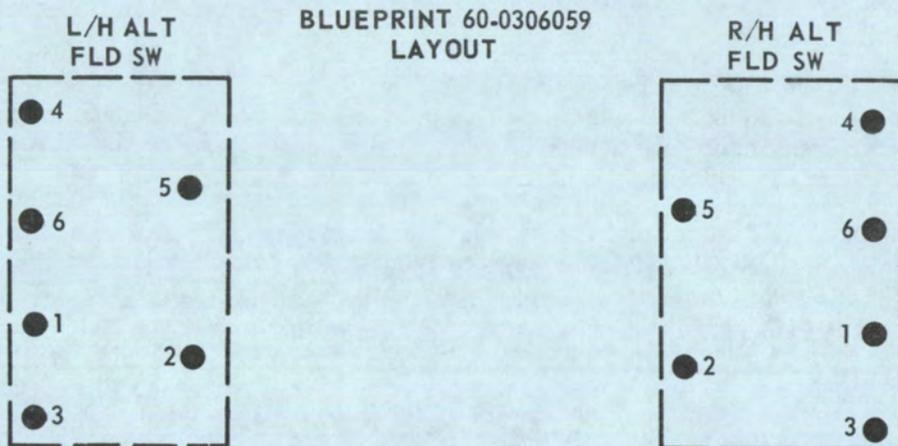
1 PRECAUTIONARY LANDING ■ As pilot entered traffic pattern at night, landing gear was lowered, landing lights were turned on, and flaps were lowered. As flaps were being lowered, complete electrical failure occurred. Maintenance inspection revealed that battery monitoring kit was wired incorrectly. *Airworthiness Directive 72-19-4 gives authority for installation of the battery monitoring kit on T-42 aircraft. However, blueprints furnished with the battery monitoring kit do not show numbers assigned to switch contact points. Consequently the individual applying the kit can wire the switch incorrectly,*

which will cause the battery to function improperly and allow the alternator to drop off the line, resulting in complete electrical failure. If you have not yet received a letter from USAAVSCOM, St. Louis, MO, correcting this wiring discrepancy, the following should be accomplished:

The above drawing, if positioned over drawing on blueprint 60-0306059, will indicate the proper numbering sequence for installing wiring to switch terminal.

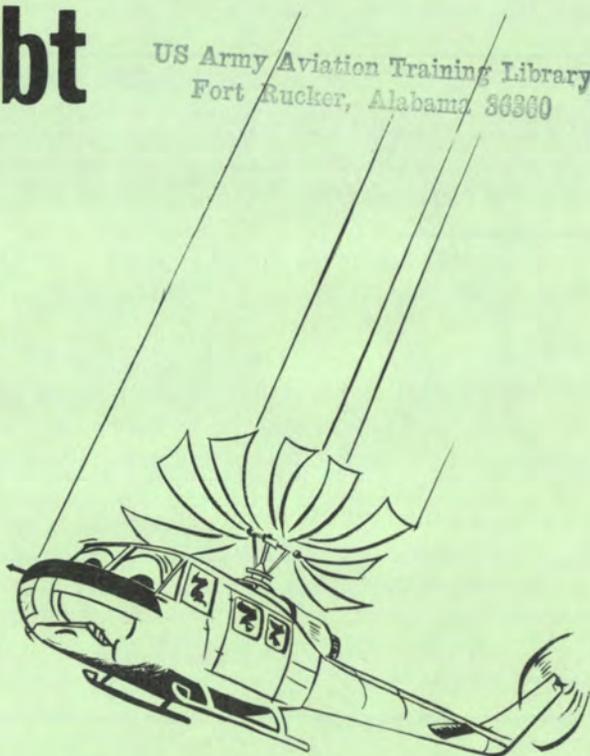
At approximately 50 feet agl, the SP executed a moderate deceleration and the aircraft entered a high vertical rate of descent. The IP then assumed full control, reduced collective pitch to regain rotor rpm, and attempted to cushion the aircraft on the ground. On ground contact, the main rotor blades severed the tail boom.

The IP was aware of the low airspeed and up collective at a sufficient altitude to have taken timely and proper corrective action. The low airspeed and reduced rotor rpm coupled with a high sink rate were allowed to progress to a point beyond which a safe power recovery and/or successful completion of the autorotation could be made. The IP should not have attempted to salvage a substandard autorotation and should

have either initiated a go-around procedure or executed a termination with power.

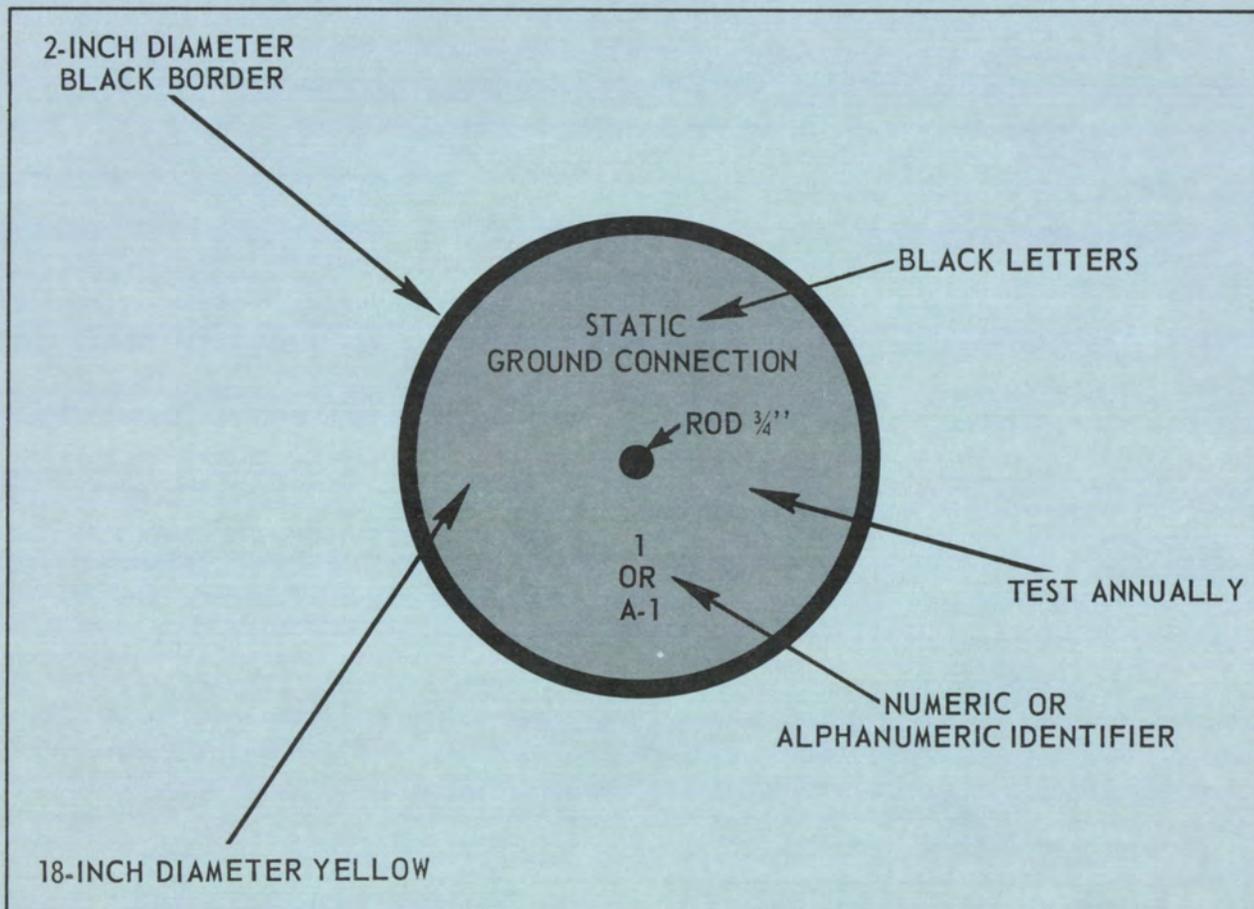
CORRECTION—Reference page 13, paragraph entitled STATIC ELECTRICITY, of the HELICOPTER RAPID REFUELING STUDY published by USAAAVS in September. The frequency of inspection of ground points is annually and the date tested and Ohmic reading will be maintained in a log, not marked in the circle as the text reads. (Reference TM 10-1101, C1.) The diagram at the top of page 13 should be as shown here:

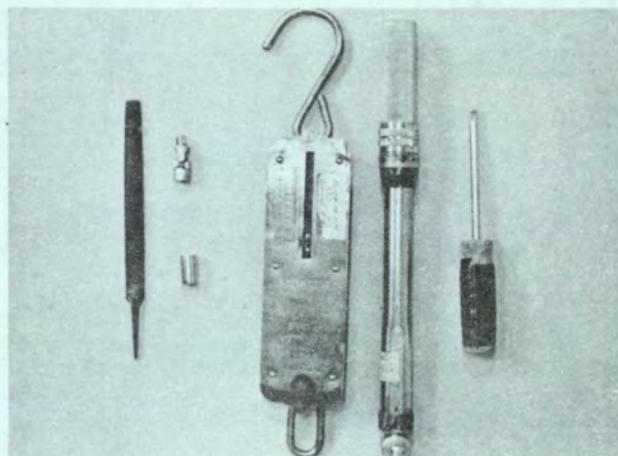
THESE FOREIGN OBJECTS

were found inside a UH-1D tail boom during a preflight inspection. The pilot found these objects by placing his ear close to the tail boom, hitting the bottom side, and listening for rattling noises.

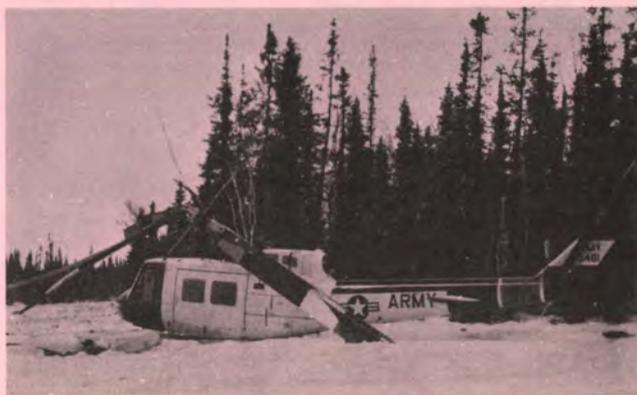
Chalk 8 initiated his approach with Chalk 9 and 10 in a trail formation. On short final, Chalk 8 created a blowing snow condition, causing Chalk 9 to make his landing in a whiteout condition. The pilot of Chalk 9 continued his approach to his

intended landing point, which had become obscured by blowing snow. About 20 to 30 feet agl, the pilot lost all visual ground reference and the aircraft struck the trees, then rolled to the left in a nose-low attitude. The crew and passengers of Chalk 9 were thrown around violently, but were able to exit the aircraft uninjured.

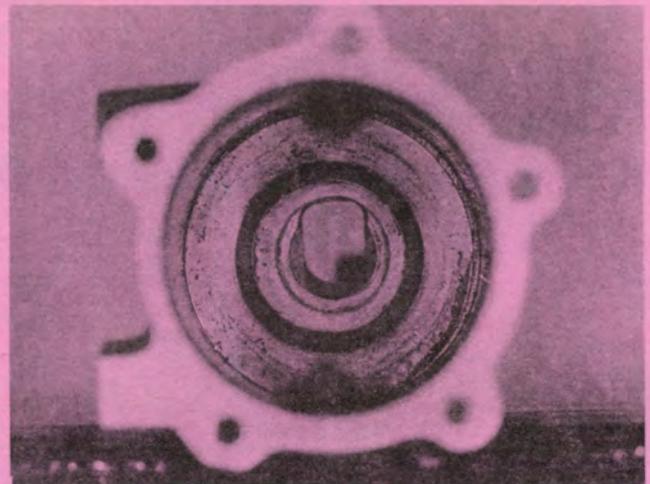
▲ Close-up showing compound and dirt collected inside return spring and cylinder. ▶

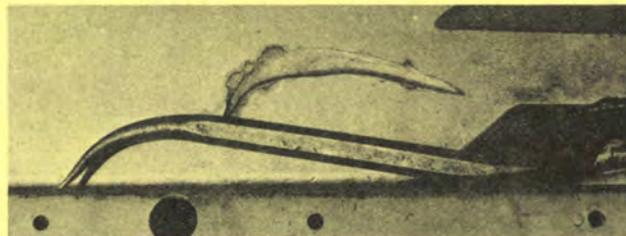
A UH-1H crew chief was inspecting his helicopter when he noticed something wedged between the main transmission and side structural panel. Removal of the panel revealed this damage. It is suspected the cotter key extractor was dropped into the transmission well while work was being done in the area of the main rotor hub assembly 25-30 hours before its discovery. Damage resulted in replacement of the main transmission. Evidently, no toolbox inventory was made.

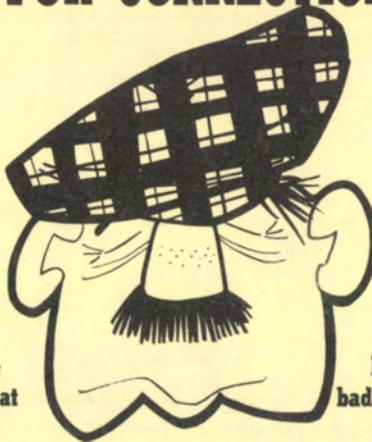
Has trouble seeing
what he is looking at

Frequently passes
bad (maintenance) checks

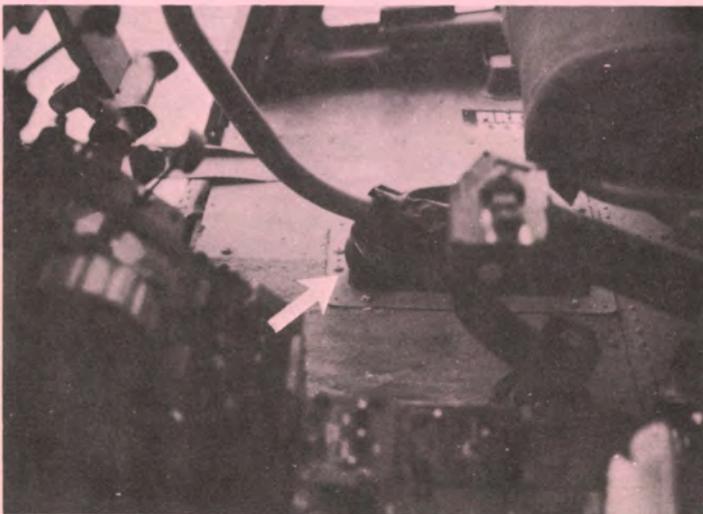
WHERE'S THE ASHTRAY ?

Have you ever considered an ashtray a widowmaker? Following a recent night flight at a National Guard facility, the maintenance officer found an ashtray lying under the pilot's pitch and roll stick of a CH-47 Chinook. An operational check revealed only 3½ inches of forward cyclic available. The crew chief indicated that the ashtray had been in its appropriate place prior to takeoff that night. The aircraft had been flown for approximately 2 hours, with a crew change after 1 hour, without shutting down.

Luckily, this did not cause an accident, but it could have.

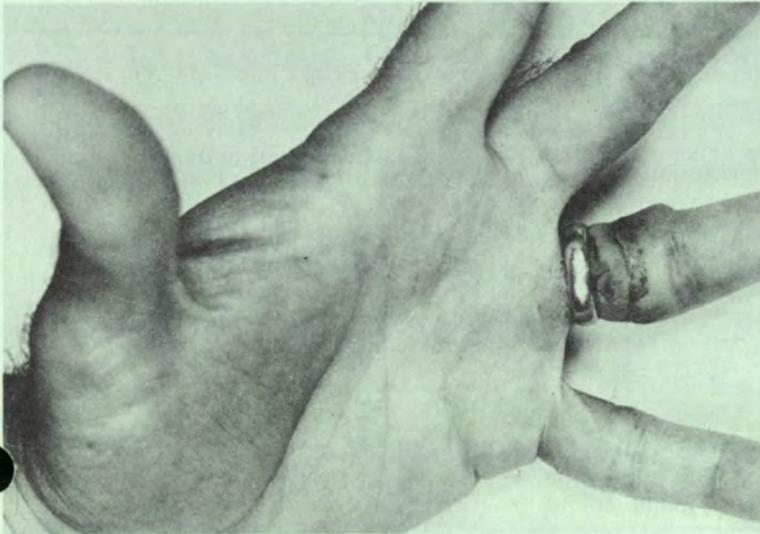
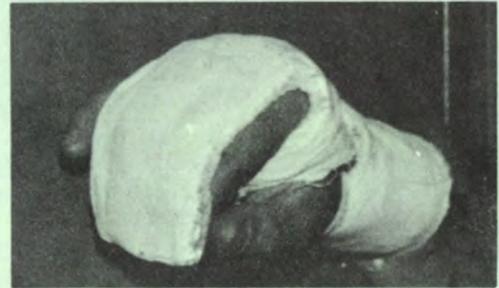
HANDS AND MACHINES

Whether you're a pilot, mechanic, or anyone who works around aircraft or machinery, it's always a good idea to remove your jewelry beforehand. Save this picture and show it to that suspicious wife when she asks why you're not wearing your wedding band which you forgot to replace after your job was done.

The owner of this hand was preflighting an OH-13 when he slipped and fell. His wedding band caught on a projecting piece of metal and dug into his flesh, causing a most painful injury.

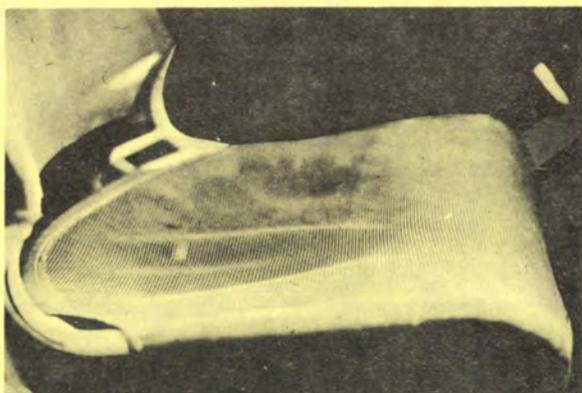
SAFE OR UNSAFE?

This UH-1 seat may be safe to fly in if you are about an axe handle wide in the posterior. But if you have an accident, you could be

hurtin' for certain regardless of your measurements.
