FLIGHT FAX

A USAAAVS PUBLICATION

VOL. 4, NO. 1 ■ 8 OCTOBER 1975

mishaps for the period of 19-25 SEPTEMBER 1975

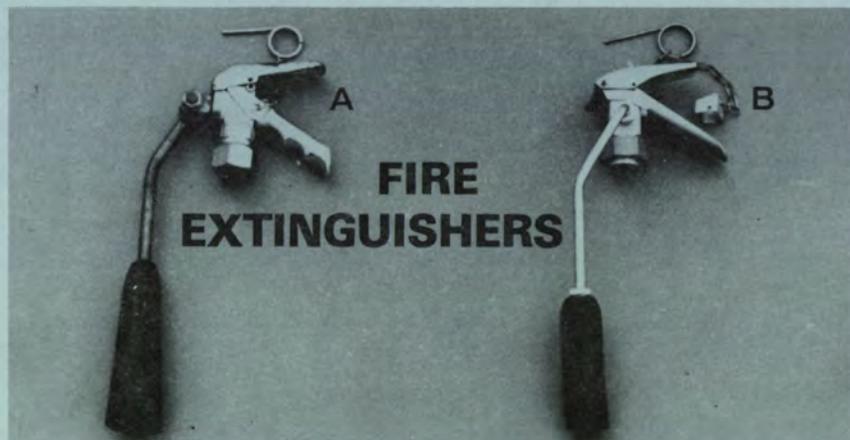
Do you know that fewer than 10 percent of all Army aviators/crew chiefs are aware that there are two types of fire extinguishers installed in AH, UH, and OH type aircraft? These extinguishers operate differently. The one with the brass head (A) requires only the pulling of the pin and squeezing of the handle, whereas the aluminum head variety (B) requires that the pin be pulled and the metal block be removed, which will then allow the handle to be squeezed.

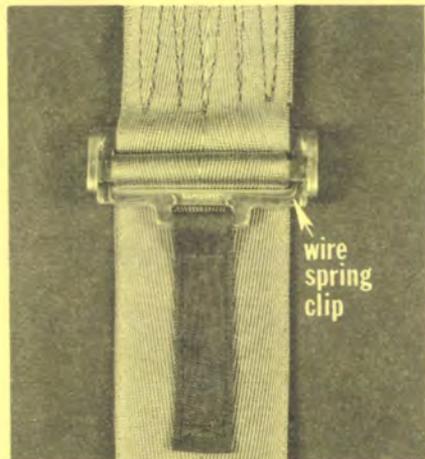
Seatbelt "Goof"

USAAVS has received a Maintenance Advisory Message (211730Z May 76) about CH-47 and UH-1 passenger seatbelts, NSN 1680-00-447-9504. These seatbelts are supplied under contract DAAJ01-75-C-1138 and made by Kings Point Manufacturing Company. The webbing retarders (wire spring clips) are missing from the webbing adjustment hardware found on the two halves of the seatbelt. Without the webbing retarders, the seatbelts slip out of adjustment and become loose. USAAVS accident/injury experience data prove conclusively that a loose belt may increase the severity of injury. Recent seatbelt shipments could be from more than the cited contract; therefore, all seatbelts with the above NSN should be inspected. The webbing retarder, NSN 1680-00-853-5464, must be requisitioned from Kelly Air Force Base (FBZ), San Antonio, Texas 78241. The cost is 14¢ each (two per belt) and should be attached in accordance with TM 55-1500-204-25/1, Chapter 3, Section IV. USAAVS has also learned that the webbing retarders are missing on some pilot/copilot seatbelts. All belts should be checked before flight.

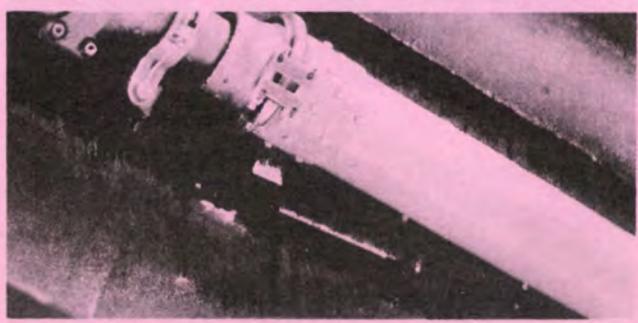
After replacing Dzus fastener on tail rotor drive shaft cover, sheet metal personnel left a rivet bucking bar on tail boom under drive shaft cover between No. 2 and No. 3 tail rotor hanger bearings. Two weeks later, aircraft was preflighted, maintenance operationally checked, and flown one hour on test flight. The following week, maintenance personnel, while washing aircraft, found bucking bar. The test flight brought the bucking bar into contact with the third section of the tail rotor drive shaft and V clamp. The bucking bar gouged the shaft and attaching clamp, requiring replacement of both. The habit of tool inventory could be the single most important element in eliminating FOD. Preflights are an essential part of the Army's maintenance inspection system.

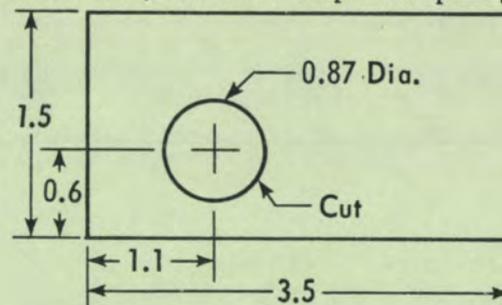
To keep birds from entering the OH-58A tail boom in the vicinity of the bellcrank assembly, NSN 1560-00-125-4271, and the connecting link, rigid, NSN 1615-00-131-6386, AVSCOM has provided a fix. This fix can be found in the August 1975 EIR and Maintenance Digest, TB 43-0001-2-4, pages 8 and 9. Data contained in this TB is quoted here for your information.

"To eliminate this problem, a fine mesh nylon screen (window screen) may be locally purchased (cost \$0.40 per square yard) to close up the sheet metal hole through which passes the tail rotor pitch connecting link. The following dimensions may be used (see figure below).

"Clean sheet metal area around hole. Bond screen to sheet metal with Pro-Seal, item 204, table 1-1 in TM 55-1520-228-20. To prevent fraying, Pro-Seal edge of hole. Total man-hours installation time, one hour. Inspect on preflight."

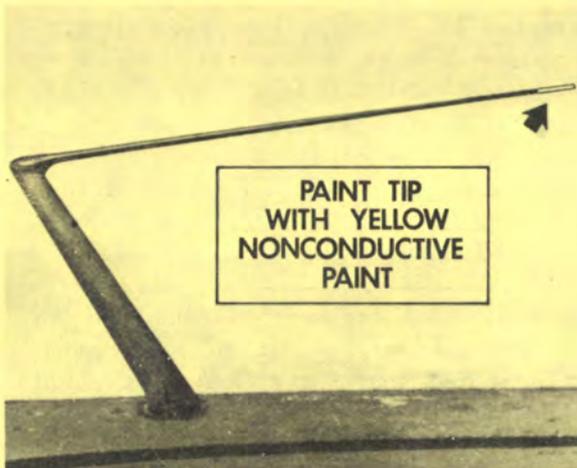
SECOND FM ANTENNA—The FM antenna on top has a way of getting under your skin—like when you back into it while you're working around the main rotor blade. That folded whip or inverted L antenna has a sharp end that'll get to you.

It's a good idea to paint the antenna yellow to attract attention to it. Paint only 3 inches of the tip. Use a nonconductive paint.

You might even stick a rubber ball or piece of styrofoam on the tip. If you do, be sure to attach a REMOVE BEFORE FLIGHT streamer to the safety item. —From PS MAGAZINE, Issue 278

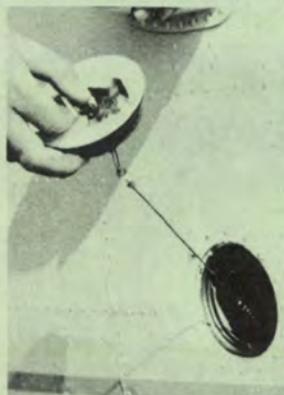
PHOTO 1

Fuel exhaustion caused a recent OH-6A forced landing. The engine failed after 45 minutes of flight. The pilot had no prior warning because the fuel quantity gauge was not functioning properly and the low fuel warning light did not come on.

■ Open the filler cap and lift it away from the aircraft (see photo 1). A chain assembly connects the cap and the flapper valve. The cap must be pulled out only far enough to open the valve to its maximum open position which is about 45 degrees.

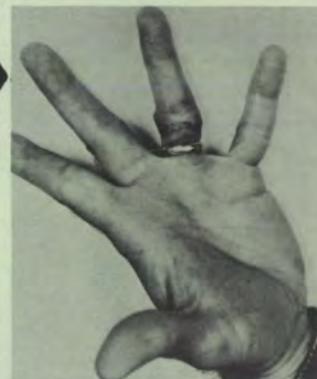
The owner of this hand was preflighting a helicopter when he slipped and fell. His wedding band caught on a projecting piece of metal and dug into his flesh.
