FLIGHT FAX

A USAAAVS PUBLICATION

VOL. 5, NO. 1 ■ 6 OCTOBER 1976

U.S. ARMY AGENCY FOR AVIATION SAFETY
 FORT RUCKER, ALABAMA 36362

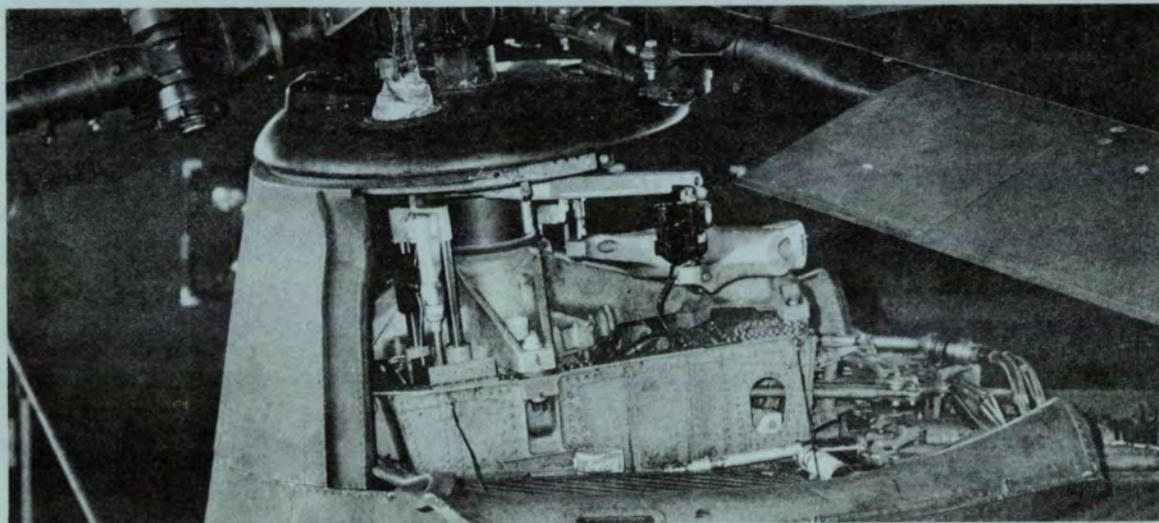
Foreign objects come in all shapes and sizes and are found in all types of aircraft. The U.S. Navy has an outstanding FOD prevention program, which includes tool control. But mistakes will happen. A Navy safety officer recently took this photograph after he saw several objects lying on the helicopter work platform. Think of what could have happened if these items had not been removed and had lodged in the push-pull tubes of the control system. FOD can be prevented, but it's a job for all hands—from supervisors and inspectors to the men who maintain and fly the aircraft. —Thanks to G. L. Coffee, commanding officer, Fleet Composite Squadron ONE

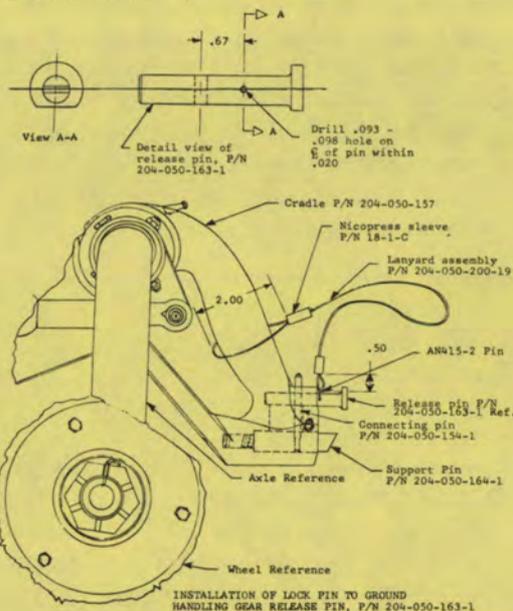
This modification will assure that the support pin is fully engaged on the skid tube and prevent the ground handling gear from inadvertently disengaging from the skid tube.

As a result of discussions with AVSCOM concerning ground handling gear problems, it has been determined that the following modification is the most expeditious one that can be accomplished in the field to reduce this hazard. It is recommended that UH-1/AH-1 ground handling gear users modify their gear accordingly (figure 1).

■ Measure, mark, and drill a .093-.098 hole in the release pin as indicated in figure 1, using a 3/32-inch bit.

■ Lanyard Assembly, P/N 204-050-200-19, shown in figure 1 is not available in the supply system. The lanyard assembly can be fabricated using a

■ Secure lock pin, P/N AN 415-2, on the other end of the lanyard, and then install it in drilled hole in the release pin, P/N 204-050-163-1. To release ground handling gear from skid tube, pull lock pin from hole in release pin, and press release pin to remove support pin from fitting on skid tube.

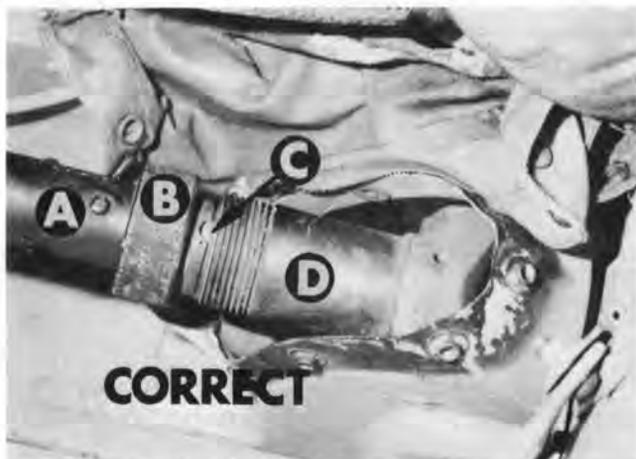
**CORRECT**

- A-Adapter tube (collective stick)
- B-Knurled knob
- C-Alignment boss (lug)
- D-Collective elbow

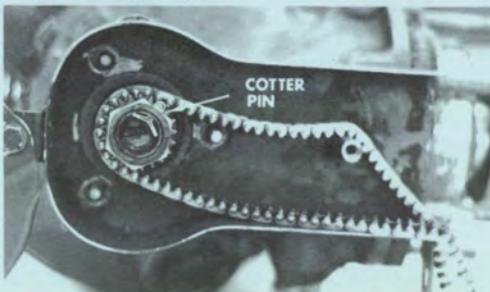
The mechanic failed to install a cotter pin in this silent chain drive sprocket retaining nut—the TI failed to catch the error on his inspection—and a \$95,000 major accident occurred with four injuries.

The nut backed off the drive shaft and jammed against the sprocket guard, causing the control pedals to stick.

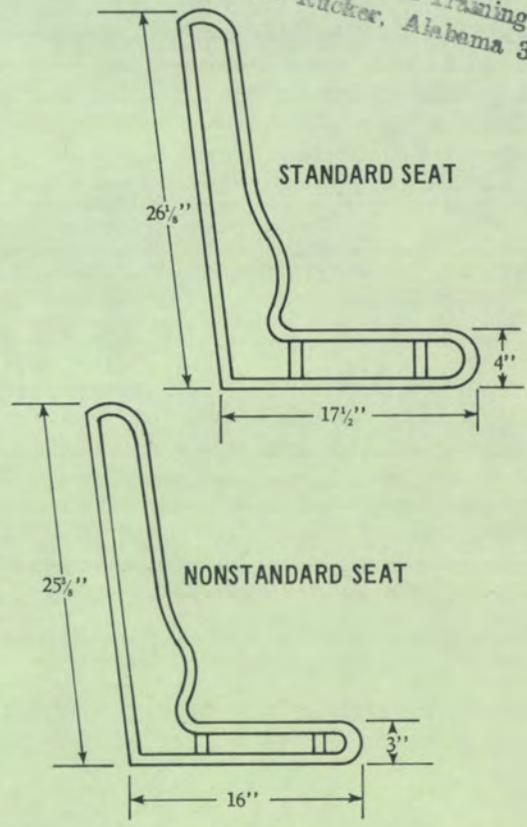
FIGURE 1

Since the seats installed in the aircraft are not marked with a part number or a stock number, determination as to whether or not they are standard will have to be made by checking seat dimensions (see figure 1).

NOTE: The manufacturer has changed the part number of the standard seat from P/N AL 1040-55-00 (shown in TM 55-1520-210-34P, dated April 1974, figure 37) to P/N AL 1040-60-00.

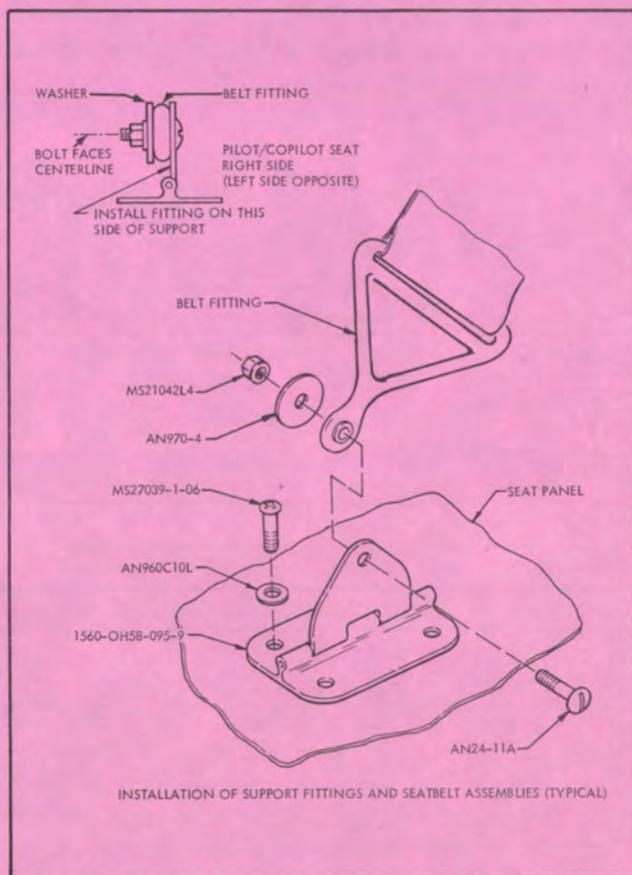
MWO 55-1520-228-30-19, Improved Seatbelts and Attachment Points (OH-58A helicopter), figure 4 (reproduced here), shows an exploded view and an end view of the support fittings and seatbelt assemblies for reference purposes to insure correct installation of the pilot and copilot lapbelts. As can be seen, the lapbelt end fitting should be located between the hinge support assembly and the washer (AN 970-4). With the retaining nut installed, the lapbelt fitting bushing is then held in place by the washer on one side and the hinge support assembly on the other. However, when Murphy entered the picture, the mechanic inadvertently positioned the washer between the hinge support assembly and the lapbelt end fitting. During flight in turbulent air, the retaining nut (MS 21042L4) pushed the bushing out of the lapbelt end fitting, allowing the belt to come loose from the hinge support assembly.

USAAVS recommends an inspection of OH-58A pilot/copilot lapbelt installations be made in accordance with AVSCOM message 162130Z March 77, ZFF-4, subject: Maintenance Advisory Message for OH-58A Helicopters, Improved Seatbelt and Attaching Points, message No. OH-58A-77-2. The above message also directs changes be made to: (a) MWO 55-1520-228-

30-19 by adding the words "washer," "belt fitting," and "pilot or copilot seat right side" to the cross section view in figure 4 (as has been done on the drawing reproduced here), and (b) TM 55-1520-228-23, Maintenance Manual, by adding a view showing the proper installation of the seatbelt anchor fitting to the hinge support assembly in figure 2-7 (duplicates figure 4-4 in TM 55-1520-228-20).

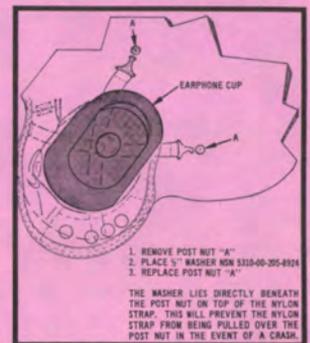
FIGURE 1

According to the U.S. Army Aeromedical Research Laboratory, there is a deficiency in the SPH-4 helmet, NSNs 8415-00-144-4981 and 8415-00-144-4985. The eyelets pull out of the nylon straps that fasten the ear cups retention harness to the helmet shell.

Specifications and drawings have been corrected to eliminate the problem. However, helmets bought under older specifications should be fixed to correct this deficiency. Figure 1 shows the "fix" and the materials needed. This "fix" applies to all helmets manufactured before FY 76.

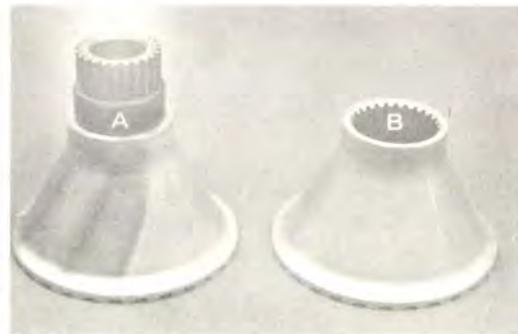
As these photos show, the new AH-1S tail rotor coupling, model 212, can be installed quite easily on model 204 hanger shafts. This is so even though the 212 couplings have 26 splines versus 24 splines on the model 204 shafts. The enlarged internal diameter on the S model coupling is responsible for this situation. The S model tail booms were "Murphy proofed" to prevent installation of the model 204 hanger assemblies.

However, nothing insures the model 212 hanger assembly itself has not been built up from an incorrect 212 aft coupling and/or an incorrect 204 male coupling. Model 204 hanger assemblies are also vulnerable to Murphy's Law by virtue of the same combination. Reference AVSCOM message 051615Z May 77 (AH-1-77-12/UH-1-77-12).

(A) Model 204 coupling, P/N 204-040-614-3, and shaft, 24 splines, P/N 204-040-602-5, for UH-1 and AH-1G/Q aircraft. (B) Model 212 coupling, 26 splines, P/N 212-040-614-1, for the AH-1S aircraft.

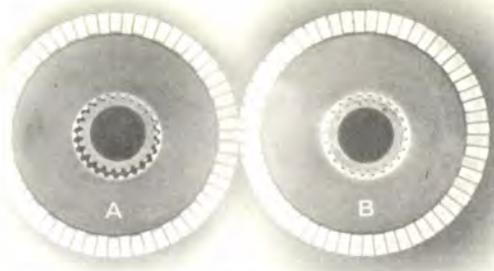
(A) 204 shaft incorrectly mated with 212 coupling.
(B) 204 coupling correctly mated with 204 shaft.

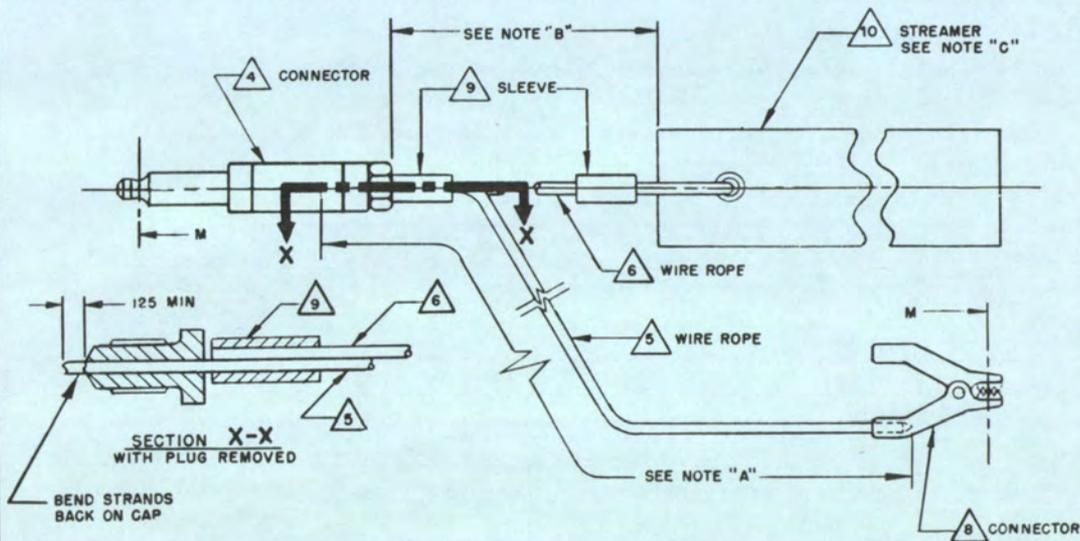
USAAAVS field visits reveal some units are using incorrect procedures for constructing aircraft ground cables. Mil Spec 27574 gives correct material for construction of

the grounding cable used in Army aviation. TM 55-1500-204-25/1, page 1-13, par. 1-52d(3), provides detailed information and alternate methods of cable construction.

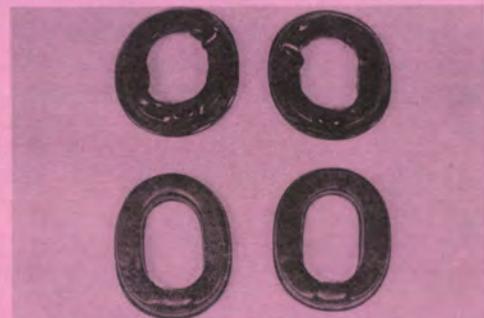
If you fly and wear a properly fitted SPH-4 flight helmet, you are afforded very adequate protection. Inadequate fitting and/or age hardening of the earcup seals will cause a drastic loss in sound attenuation. Earcups tend to harden with use. In many cases as little as three months of use can cause sufficient hardening to compromise proper protection. This hardening, as with loss itself, is insidious. The only way to properly check for hardening is to compare your earcups with a new set. If you notice it's time for a change, request a new pair.

Replace hardened and wrinkled earcups.

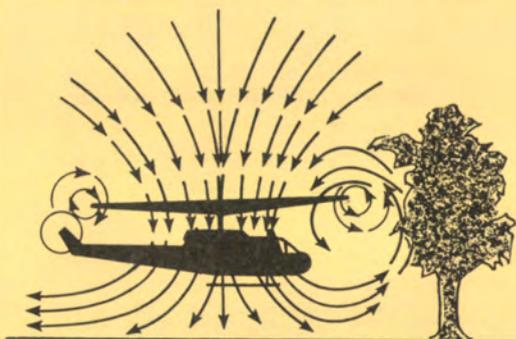
FIGURE 1

When a helicopter hovers, the rotor system moves a tremendous volume of air every second. This air, drawn from the surrounding air mass, results in a giant pumping process. When an obstacle is placed near the air flowing through the rotor system (figure 1), it causes the

airflow to swirl vertically upwards and then back down through the rotor. If the object happens to be a tree with flexible

limbs, then branches and leaves may be sucked into the rotor. This situation is more likely to occur during hover in a confined area or when landing downwind without adequate rotor clearance.

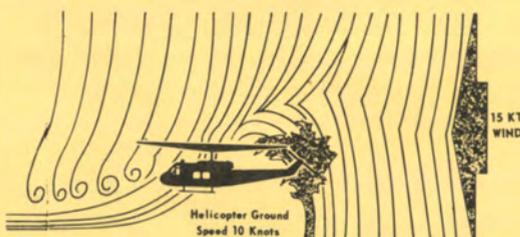
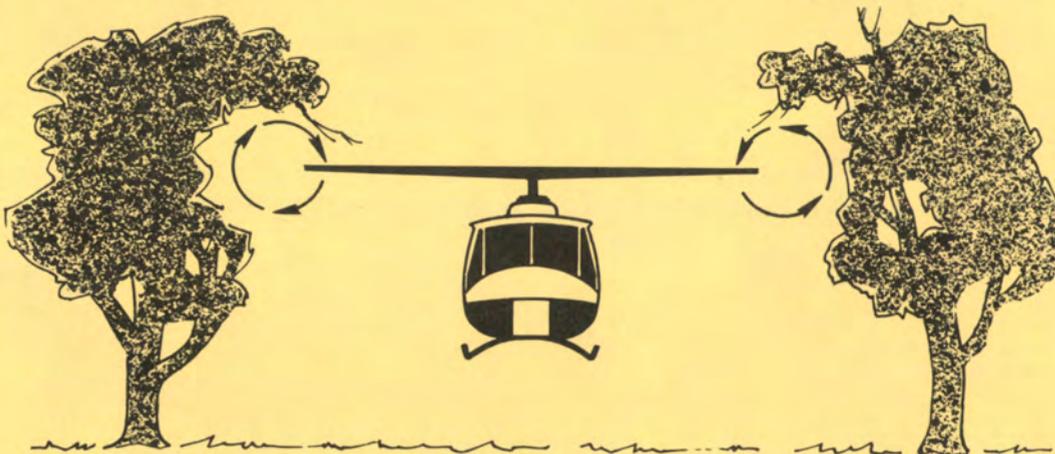
FIGURE 2

During an NOE approach downwind into a confined area, the airflow through the rotor at translational lift will likewise tend to draw tree limbs into the rotor, particularly from the rear (figures 2 and 3) when passing through a narrow opening in the trees.

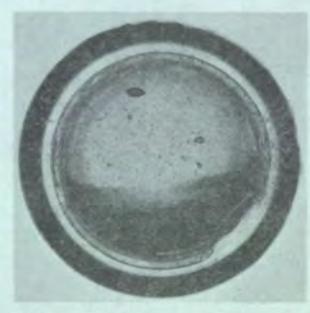
STAINED SIGHT GLASS

Recent visits to the field show that we are still flying aircraft with excessively stained sight glasses. These stained sight glasses can give a false level indication and the gearbox will appear to have sufficient lubrication. An insufficiently lubricated gearbox or transmission can lead to a catastrophic accident. It is the responsibility of all crewmembers and maintenance personnel to inspect and correct deficiencies in accordance with published TMs.

Periodic inspections as specified by the PMD, PMI, PMP, and the dash 20 should be followed to prevent failures from this cause.

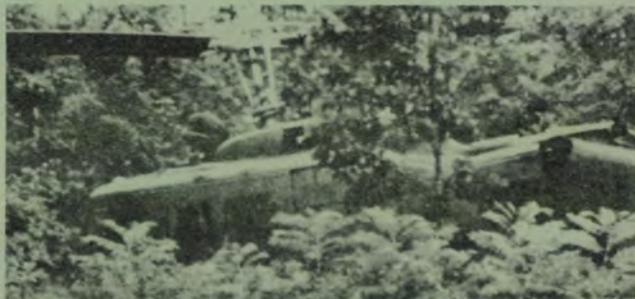
Failure of this P1 multiplier valve connector caused this.

Since 1971, 12 T53-L-13B-powered helicopters have had P1 multiplier connector failures. Six of these resulted in accidents. Emergency procedures for low side governor failure, where altitude and time were available, would have given the pilot power for a controlled safe landing.

The P1 multiplier bellows senses pressure/altitude changes and automatically adjusts engine fuel flow. When the P1 multiplier fails, the pressure compensating linkage moves toward the minimum flow position and fuel flow is reduced. The resultant fuel flow may be enough to sustain engine operation, but it will not provide the required power to maintain flight.

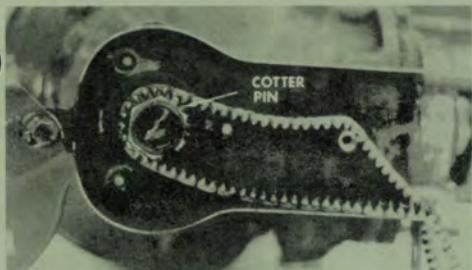
COTTER PIN INSTALLATION

A recent issue of FLIGHTFAX carried an item describing an accident caused by the failure of a mechanic to install a cotter pin in the silent chain drive sprocket retaining nut. The picture showed an incorrect installation of a cotter pin. The cotter pin should be installed through the hex nut and control quill and bent flat against hex face of retaining nut, in accordance with TM 55-1520-210-20, chapter 9, par. 9-15(g), step 4.
