FlightFax

REPORT of ARMY AIRCRAFT ACCIDENTS

October 1994 ♦ Vol 23 ♦ No 1

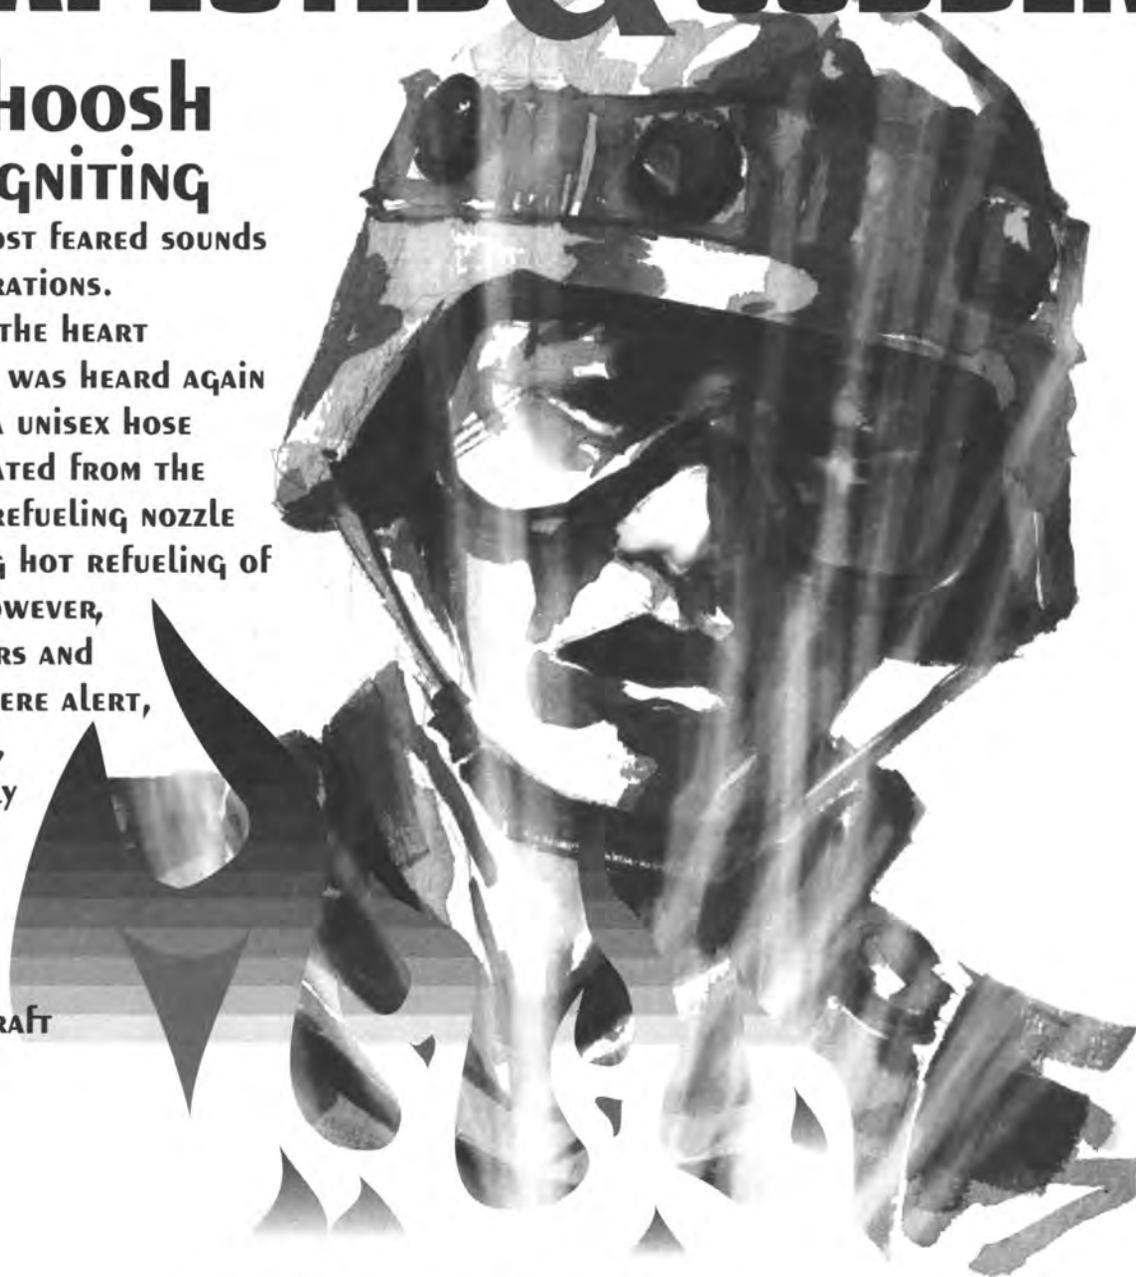
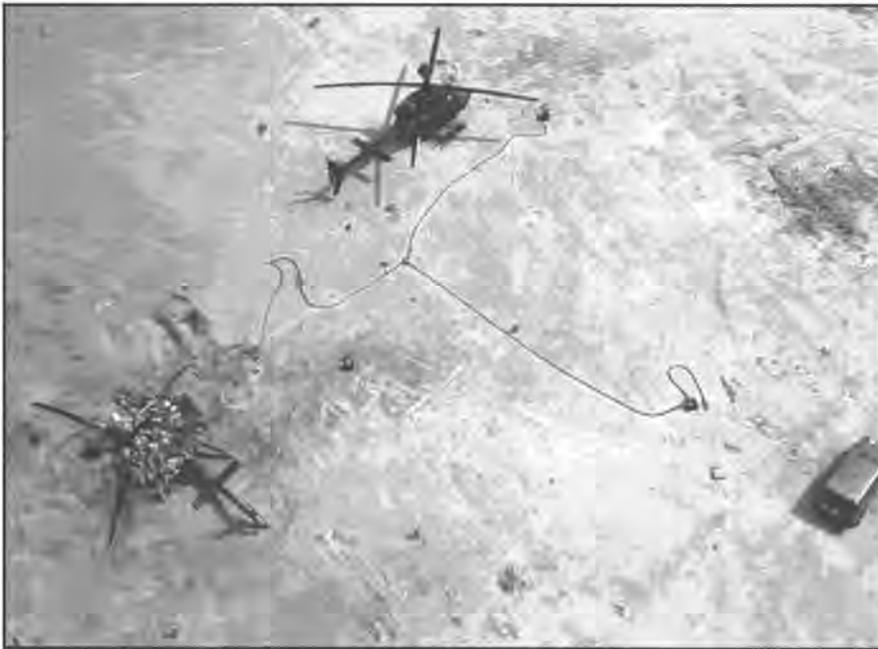
UNFORTUNATELY, THE HEART
STOPPING SOUND WAS HEARD AGAIN
RECENTLY WHEN A UNISEX HOSE
COUPLING SEPARATED FROM THE
CLOSED-CIRCUIT REFUELING NOZZLE
COUPLING DURING HOT REFUELING OF
AN OH58D. HOWEVER,
THE CREWMEMBERS AND
FUEL HANDLERS WERE ALERT,
REACTED QUICKLY,
AND MIRACULOUSLY
ESCAPED WITH
ONLY MINOR
INJURIES. THE
MORE THAN
\$6 million AIRCRAFT
WAS DESTROYED
BY THE FIRE.

A UH-60, which was sitting where the vehicle in the photo is located, was refueling two OH-58D aircraft. At refuel point 1, the fuel nozzle separated from the hose coupling. Pressurized fuel sprayed over the refueler and the aircraft and ignited.

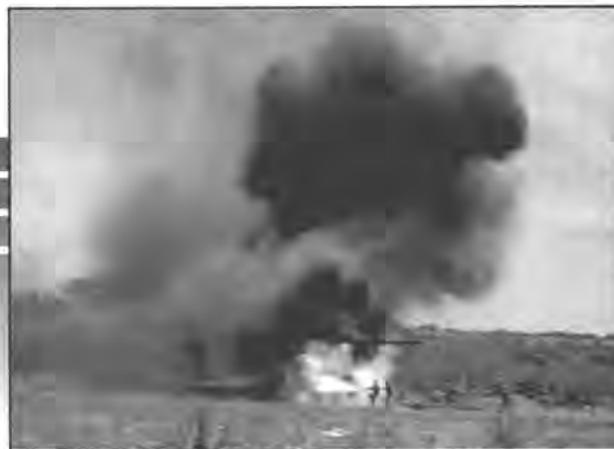
This photo at 14:52:30 shows how quickly aircraft was destroyed.

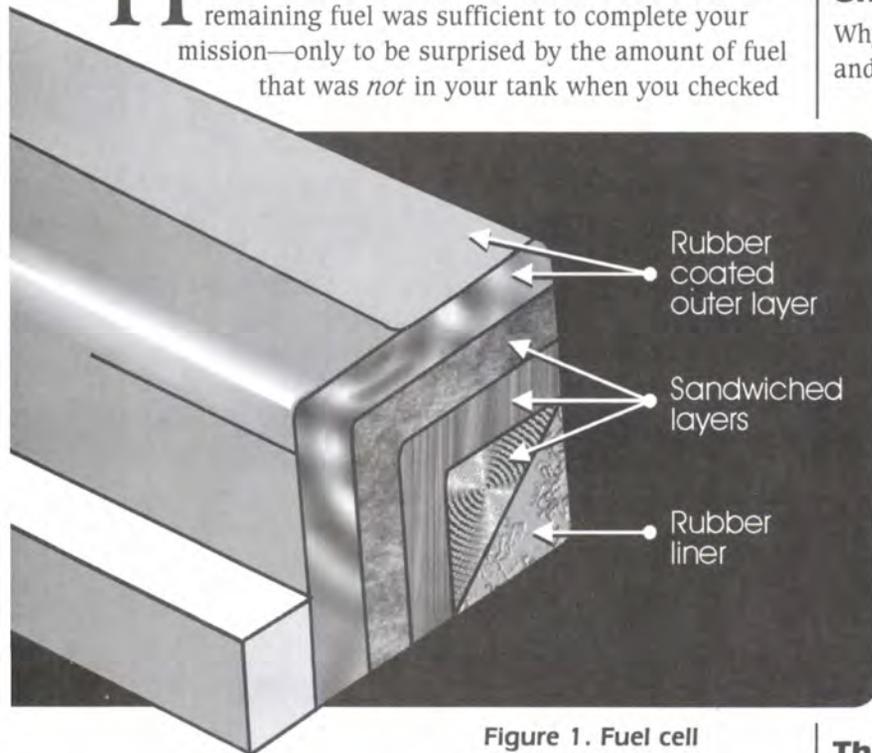
Figure 1. Fuel cell

The fuel cell in OH-58A/C helicopters is a self-sealing bladder type. Sandwiched between an outer rubber-coated composite layer and an inner rubber liner, the self-sealing bladder is constructed of several layers of strong, flexible composite type material and a gel designed to act as a sealant in case of projectile penetration (figure 1).

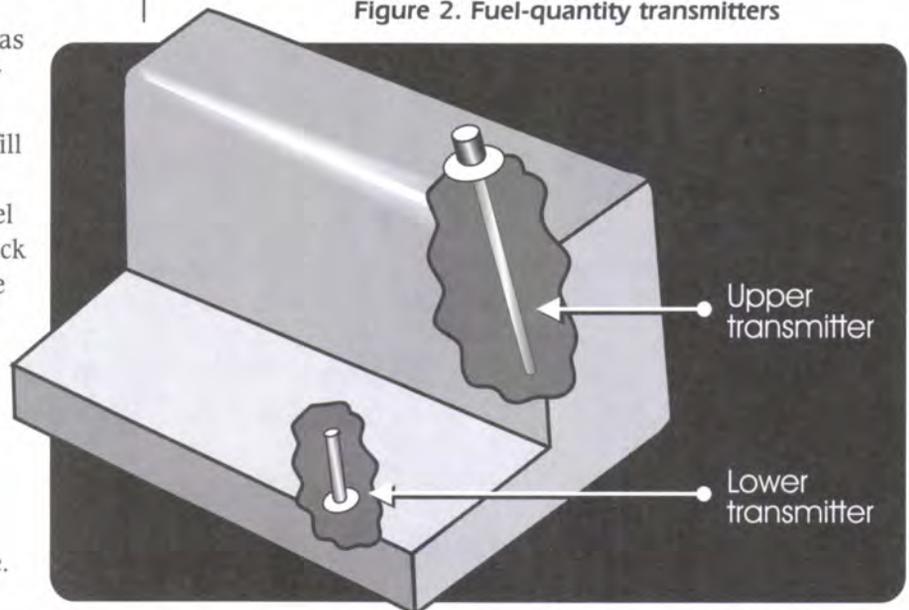
Figure 2. Fuel-quantity transmitters

The fuel-quantity transmitters (figure 2) are located toward the center of the fuel cell, and based on the depth of the fuel, they measure the amount of fuel in the tank. In each of the incidents, more than half of the fuel was contained in the walls of the fuel cell. Once the fuel level fell below the level of the defect in the walls, the gauge indications were no longer reliable and the fuel consumption rate appeared to increase.

■ **Take a fuel sample.** Take a fuel sample before every flight. If there is any sign that the fuel cell is deteriorating (for example, small black flakes present in the fuel), reject the aircraft and request that the fuel cell be inspected.

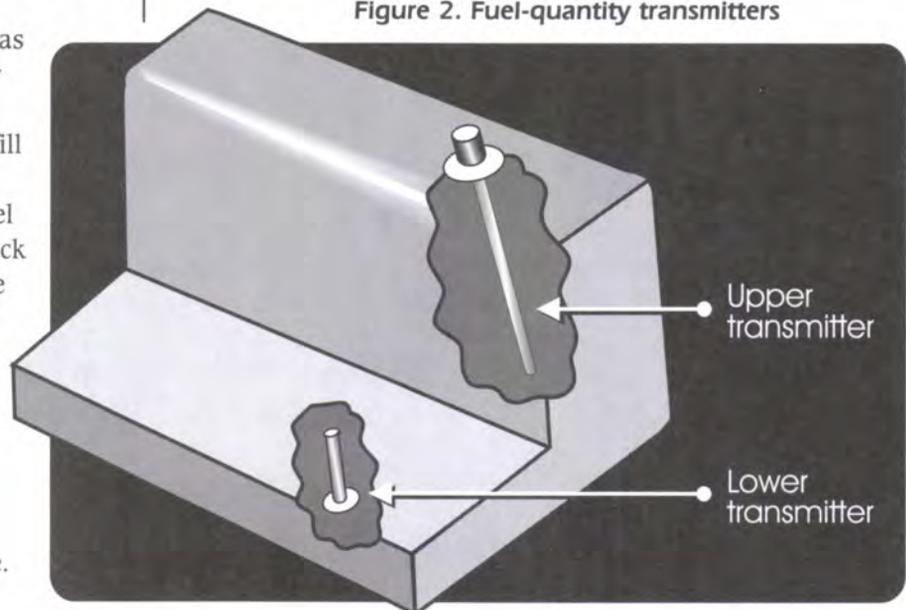
Figure 2. Fuel-quantity transmitters

The fuel-quantity transmitters (figure 2) are located toward the center of the fuel cell, and based on the depth of the fuel, they measure the amount of fuel in the tank. In each of the incidents, more than half of the fuel was contained in the walls of the fuel cell. Once the fuel level fell below the level of the defect in the walls, the gauge indications were no longer reliable and the fuel consumption rate appeared to increase.
