# Flightfax

ARMY AVIATION  
RISK-MANAGEMENT  
INFORMATION

AUGUST 1999 ♦ VOL 27 ♦ NO 8

## "Weather " or not to go?

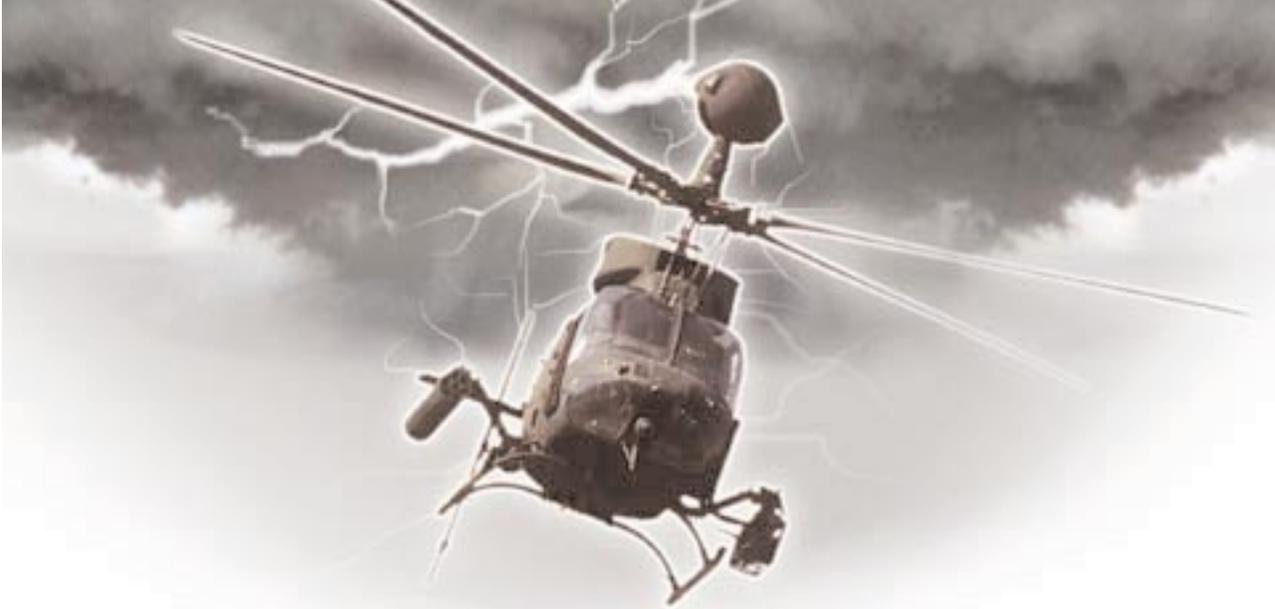
than 60,000 feet. Moisture in the lowest levels of the atmosphere becomes the fuel that fires up the thunderstorm development process. As tiny moisture particles are forced upward, condensation causes them to develop into droplets. As they collide with other droplets, they merge and grow in size. When they become too large for the updrafts to

support, the droplets begin to fall. This falling precipitation creates a **downdraft**.

As the downdraft reaches the surface, it produces a diverging pool of cool air, which becomes the **gust front** or **downburst**. A downburst with winds extending 4 kilometers or less is known as a **microburst**. Microburst, and its accompanying

On a larger scale, one of the most potentially severe events is the **squall line**. The squall line is a line of thunderstorms that can form along a front or develop 100 to 300 kilometers ahead of it. The mechanism for this event is the angle of the wind flow at about 10,000 feet. A wind flow aloft that is parallel to the front will generally keep most squall-line activity along the front. However, a perpendicular flow can cause squall-line development well ahead of the advancing frontal system. As the thunderstorms in the line develop downdrafts, downbursts may generate new thunderstorms ahead of the squall line. As the advancing downburst winds advance, they may force warm, moist air aloft ahead of it, generating a new squall line.

Strong upper-level wind flow may cause individual thunderstorms to develop rotation in their core. If a large-enough portion of the core is rotating, it's called a **mesocyclone**. Within the mesocyclone, there may exist a smaller, more intensely rotating

One of the greatest threats to aviation is that of **lightning**. As a thunderstorm develops, an electrical charge builds up in the cloud. The exact cause of this electrification is unknown, but what is known is that unlike charges attract each other. The manifestation of this attraction is the lightning stroke (or bolt), an electric discharge that can have a current as great as 100,000 amperes. A charge of this magnitude can damage an aircraft's fuselage and electrical components; it could even cause fuel combustion.

One final phenomenon associated with thunderstorms is **hail**. As the updrafts in the storm carry moisture aloft past the freezing level, water droplets freeze into ice. As these ice particles are held aloft, they pass through areas of moisture and acquire further coats of ice. This process continues until the ice buildup makes the particle too heavy to be supported aloft, and it falls. This falling particle is hail, which could be encountered aloft during flight even in areas where the freezing level is high enough that the hail melts before it hits the ground.
