Flightfax

Online Report of Army Aircraft Mishaps

Taxi Mishaps – Pay attention, They’re Preventable

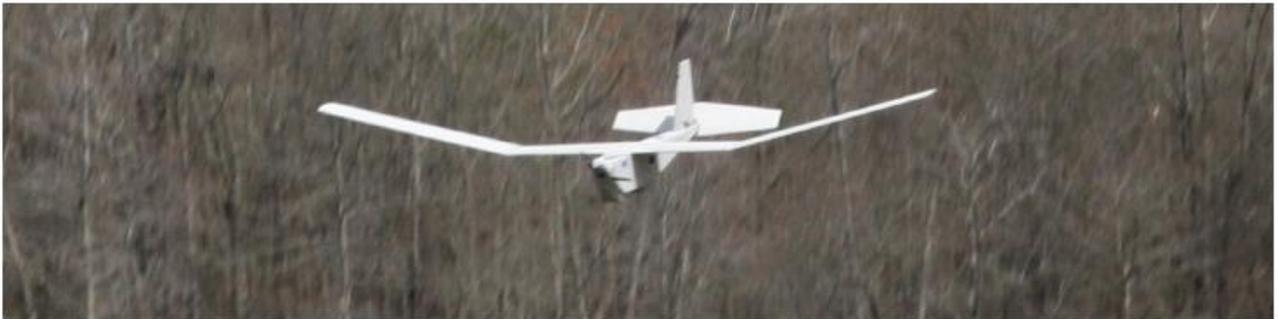
Puma is a hand launched Small Unmanned Aircraft System designed to directly support organic reconnaissance requirements of battalion and below maneuver elements. The system is man-portable and is operated by 2 trained operators. The Puma provides the ability to automatically track moving targets and to operate in a “follow-me” mode relative to the operator, thus allowing for mobile operations. The sensor is fully gimballed and simultaneously provides EO, IR, and illuminator capabilities. Puma can operate in a wide range of environments, including rain and salt water conditions.

The Puma All Environment Capable Variant (AECV) is designed for land based and maritime operations. It is capable of landing in fresh or salt water and on land and provides the operator with the flexibility to tailor missions to the specific needs of forward deployed tactical units. The Puma AECV is designed for use in rugged and austere environments, providing a highly reliable, man portable reconnaissance system requiring no auxiliary equipment for launch or recovery operations. The electrically powered system operates autonomously and carries a fully gimballed sensor system incorporating electro-optical and infrared sensors and an IR Illuminator in one modular, gimballed payload allowing the operator to keep “eyes on target”.

Wing Span	Air Vehicle Weight	Range	Airspeed	Operational Altitude	Max Altitude	Endurance	Payload	GCS/ RVT	System Design	Data Link	Flight Modes
9.2 ft	13 lbs	15 km (LOS)	23-52 mph	500 ft AGL	10,500 ft MSL	120 Min	Gimballed EO (2592x1944), IR (640x480) and Laser Illuminator (25 ft spot at 500ft AGL) and IR camera plus an IR illuminator	Handheld (GCS & RVT are interchangeable) Combined Weight- 9 lbs (13.9 lbs w/mission planning/ RSTA Laptop)	Modular, Kevlar composite, direct-drive electric motor, Li-Ion rechargeable batteries	Digital Data Link (DDL) using IP based protocol with 95 selectable channels-of which 16 may be used in an ops area-locked to specific air vehicle	Manual, Autonomous, Follow-Me
