# Flightfax

ARMY AVIATION  
RISK-MANAGEMENT  
INFORMATION

AUGUST 1998 ♦ VOL 26 ♦ NO 11

# Spotlight: AH-64A safety performance review

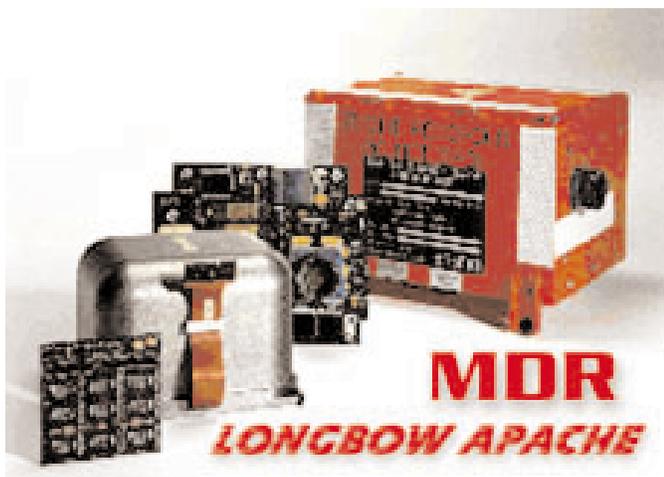
# AH-64D Longbow Apache maintenance data recorder

The digital source collector aboard the AH-64D Longbow Apache, the Maintenance Data Recorder (MDR), is not the first crash-survivable, solid-state flight data recorder placed on an Army aircraft. The MDR is, however, the first one to be fully integrated into an Army helicopter system; it was aboard the first AH-64D off the assembly line.

begins whenever a.c. power is applied to the aircraft, be it from a ground power cart, the aircraft's APU, or the aircraft's engines. Further, the MDR has a built-in test (BIT) integrated into the AH-64D diagnostics system and multifunctional displays that provides fault reporting and fault isolation for MDR failures.

With aircraft power off, the MDR is downloaded using the Soldier's Portable On-system Repair Tool (SPORT) Computer and MDR ground station software.

The MDR requires no flight-crew operational checks and only limited unit-level maintenance. The only maintenance that flight-line personnel can expect is the replacement of a line-replaceable unit, which requires the removal of two screws and one connector.

Storage of the MDR is simple. It can be stored indefinitely in a dry, well-ventilated place that is free of dust and other contaminants. All that's required is a plastic cap on the J1 connector to prevent damage to the cannon plug.
