Flightfax

ARMY AVIATION
RISK-MANAGEMENT
INFORMATION

MARCH 1999 ♦ VOL 27 ♦ NO 3

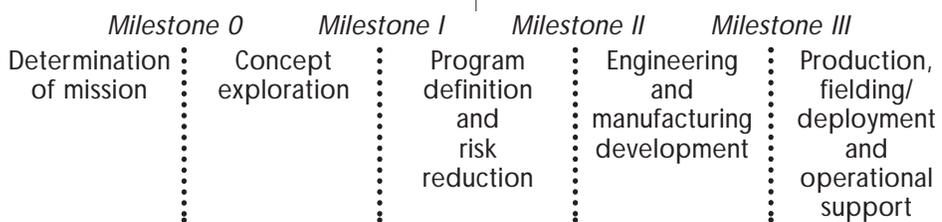
Figure 1. Life-cycle management model

Army policy dictates that system safety be applied and tailored to all Army systems and facilities throughout their life cycles. This policy is institutionalized through partnerships and coordination with Assistant Secretary of the Army for Research, Development, and Acquisition; Assistant Secretary of the Army for Installation, Logistics, and Environment; and other Army staff offices. Implementation rests with the program managers responsible for Army systems development in all stages of life-cycle management (figure 1).

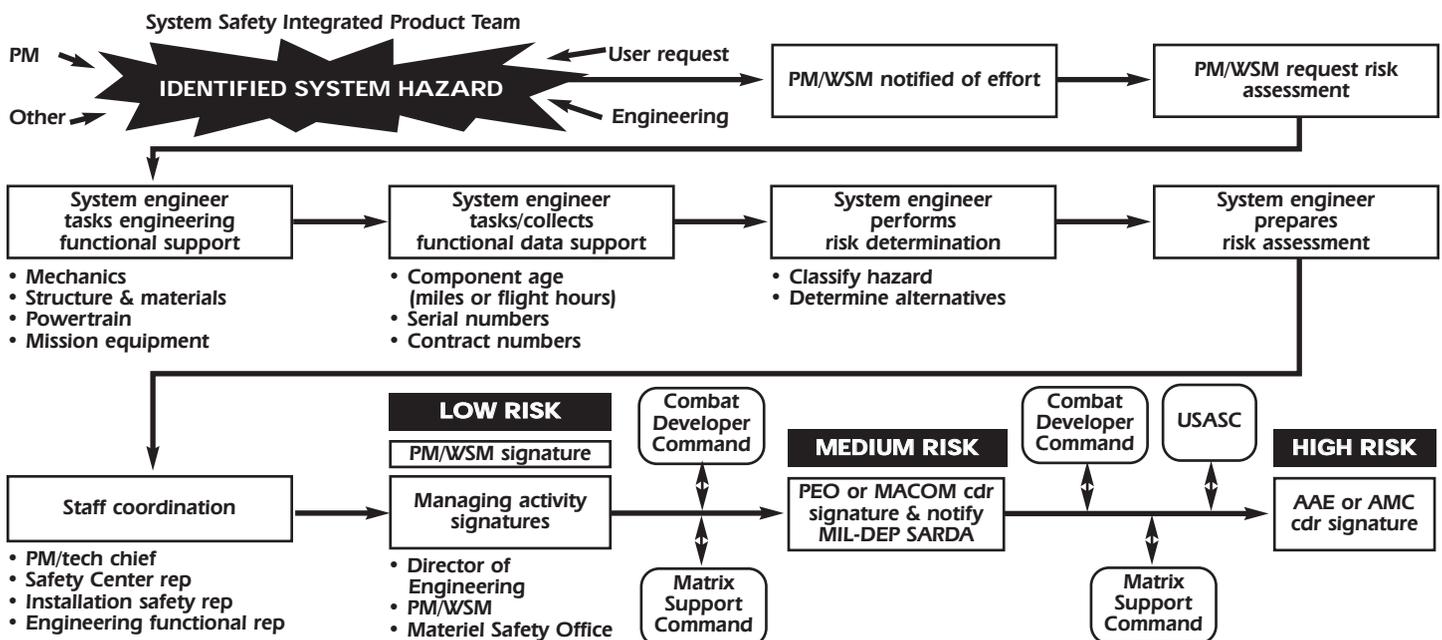
Figure 2. SSRA process (risk assessment flow)

After fielding, the PM is responsible for tracking worldwide accident and incident data, improvement recommendations, deficiency reports, and other data to correct safety hazards as they arise. Through system safety risk assessment (SSRA), the severity and probability of hazards are determined and presented to the appropriate level decision maker for risk management (figure 2). The decision-maker implements controls within the following resource constraints:
