# FlightFax

REPORT of ARMY AIRCRAFT ACCIDENTS

October 1996 ♦ Vol 25 ♦ No 1

# HGU-56/P and ANVIS: Adjusting for full FOV

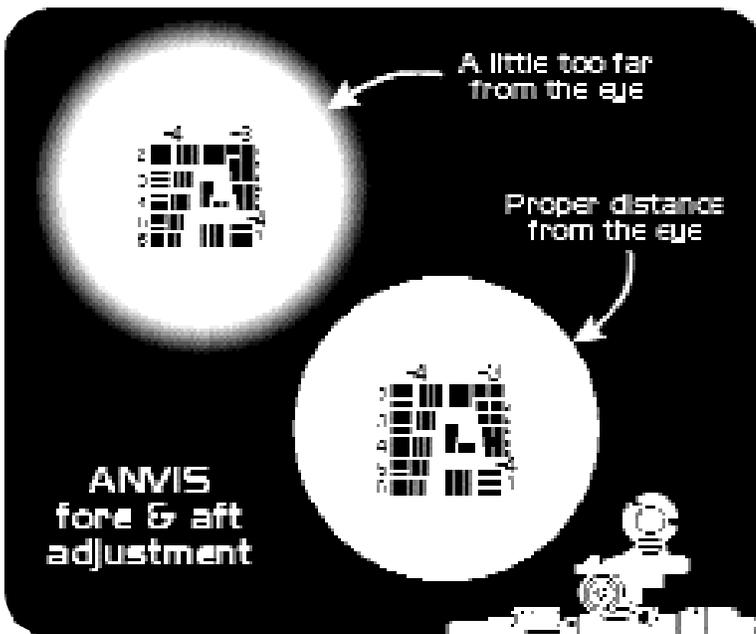
As with previous helmets, some aviators are having problems getting a full field of view (FOV) with the standard eyepiece ANVIS mounted on the HGU-56/P helmet. Interestingly, aviators wearing larger-sized helmets have reported the most incidents. This is probably accounted for by the fact that, as helmet size increases, so does eye-clearance distance. And therein lies the problem.

## What IS a full FOV .

Simply stated, you have a full FOV in each tube with ANVIS when you are looking in the center of the circular image and the outer edges of the FOV appear sharp all around the green pattern. When your eyes are on the proper optical axes and the ANVIS is at the maximum eye-relief position while retaining a full FOV, you will notice that when you move your eyes to look in any direction, the edge you fixate on will slightly blur or dim.

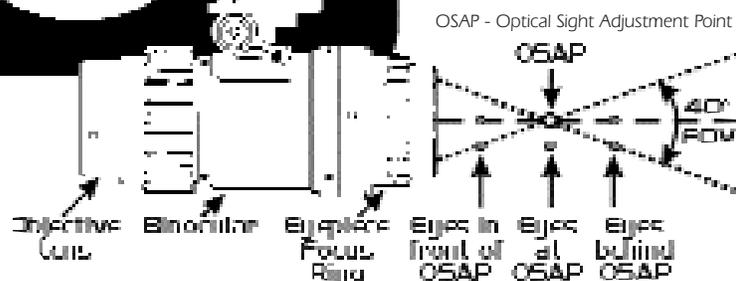
If you adjust the ANVIS IPD laterally narrower or wider than your eye IPD, you'll have what's called "partial overlapping FOVs." In this situation, the FOV area seen by each eye separately will be smaller than the total visible horizontal FOV with both eyes open. Objects seen in the right and left tubes will be aligned, but the outline of the right

and left FOVs will appear separated laterally. The less-than-total overlap will not compromise safe operation, but it may take some time for you to adapt to this way of seeing. (NOTE: "Partial overlapping FOVs" is the technique planned for

use to increase horizontal FOV in the helmet-mounted display for the Comanche.)

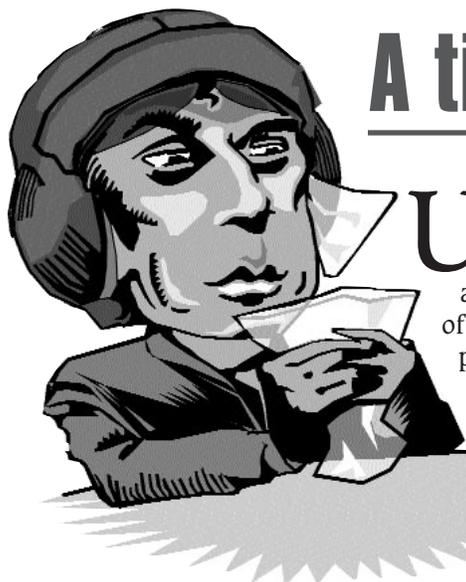
**It's confusing. The diameter of the visible opening for the original "standard ANVIS eyepiece" is slightly more than 19mm, but we call it the "15mm eyepiece." The diameter of the new "25mm eyepiece" is actually about 27mm. What's the deal?**

Trust us; you really don't want to know. To explain fully would involve discussing all manner of complicated stuff involving, among other things, distance of the pupil behind the cornea and photopic vision. Let's just agree to call the original ANVIS eyepiece "the standard eyepiece" and the more recent, larger eyepiece "the 25mm eyepiece." That way, we'll have no more confusion; we'll all understand each other.

The larger 25mm ANVIS eyepiece procured with the last ANVIS buy is a giant step toward ensuring every user a full FOV with ANVIS. However, it's going to take some time. A retrofit program for existing systems has not yet been funded, and, while all replacement eyepieces are now the 25mm design, turning in ANVIS with serviceable standard 15mm eyepieces only to change to 25mm eyepieces is not authorized.
