# Flightfax

ARMY AVIATION  
RISK-MANAGEMENT  
INFORMATION

SEPTEMBER 1998 ♦ VOL 26 ♦ NO 12

# Spotlight: UH-60 safety performance review

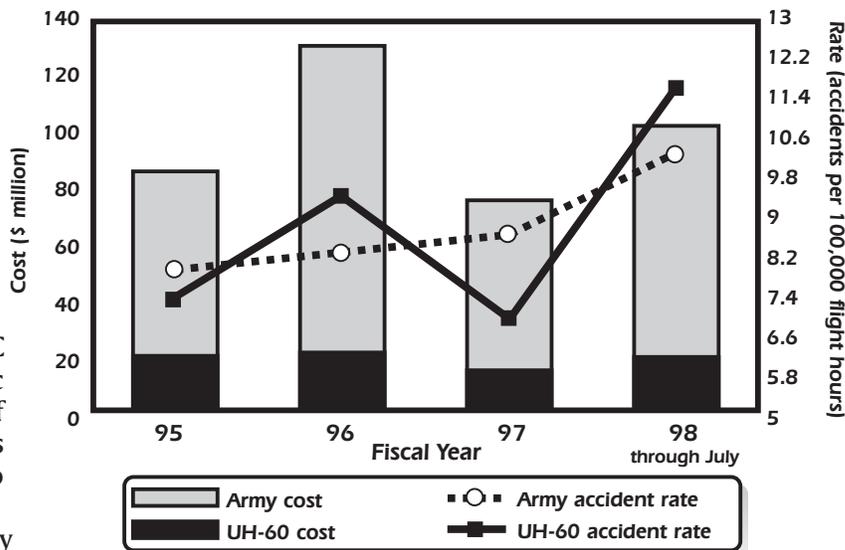
Figure 1. Rate and cost comparison of Army and UH-60 Class A–C accidents

The overall Army aviation Class A–C accident rate is on a pretty dramatic upward trend (figure 1). Through July of this fiscal year, that rate is 10.23 accidents per 100,000 flying hours, compared to FY97’s year-end rate of 8.60.

Only a cursory glance at figure 1 makes it clear that UH-60s are not having a good year. So, back to the original question: “**Is there cause for alarm?**” The answer is no, not “alarm,” but there is certainly cause for concern.

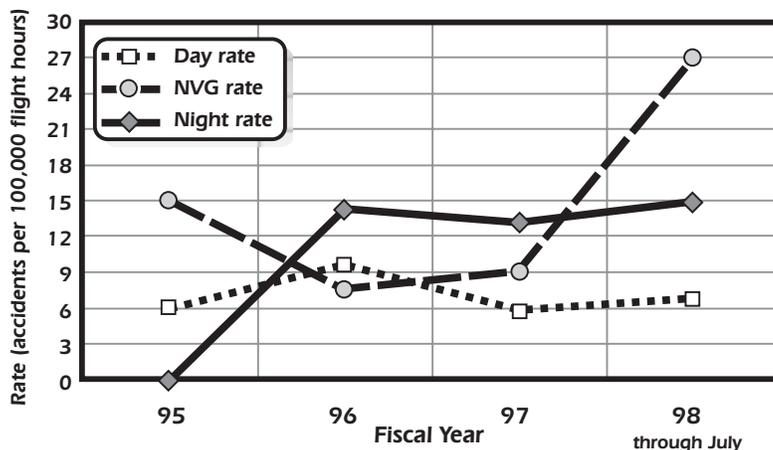
Figure 2. Comparison of UH-60 Class A–C accidents by mode of flight

When we look at Class A–C Black Hawk accidents by mode of flight (figure 2), we see a spike that could be defined as “alarming”: The NVG accident rate rose almost 300 percent during the first 10 months of FY98. However, we should take this with a grain of salt; we had only 10 NVG Class A–C accidents in 37,100 NVG hours. This is a small sample on which to base a trend.

Day rates also rose. These rises were accompanied by a rise—albeit only slight—in the percentage of accidents that happen on single-ship missions. What emerges is a trend that suggests that, in the Black Hawk community, single-ship, NVG missions are the most likely missions to end in a Class A–C accident.

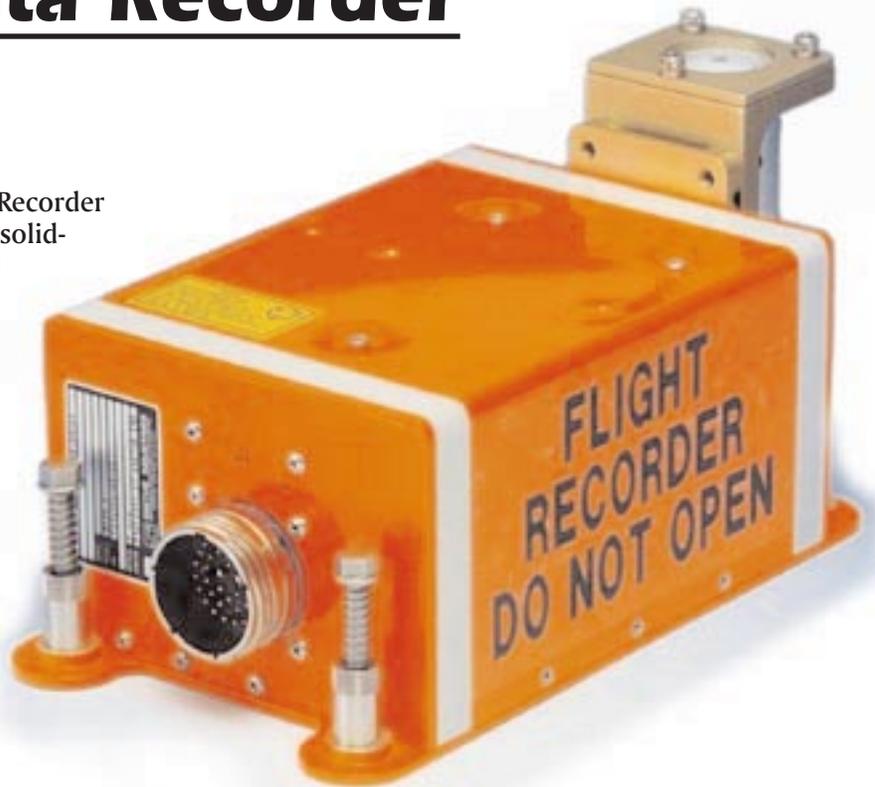
The VADR is unique among flight data recorders now aboard Army aircraft in that, unlike the others, the VADR can be reprogrammed by users at unit level.

For example, if a new flight parameter is added to the list of those already being recorded by the VADR, the Army simply ships new software upload disks to user units. Unit personnel then load the new program into each VADR right at the aircraft. This eliminates the need to ship recorders back to vendors for reprogramming.
